December 12, 2019

SUBJECT: *GEOTECHNICAL ASSESSMENT
PROPOSED SINGLE FAMILY HOME, SHOP AND DRAINFIELD
LOT 13, TYBREN HEIGHTS ROAD, KELSO, WA*

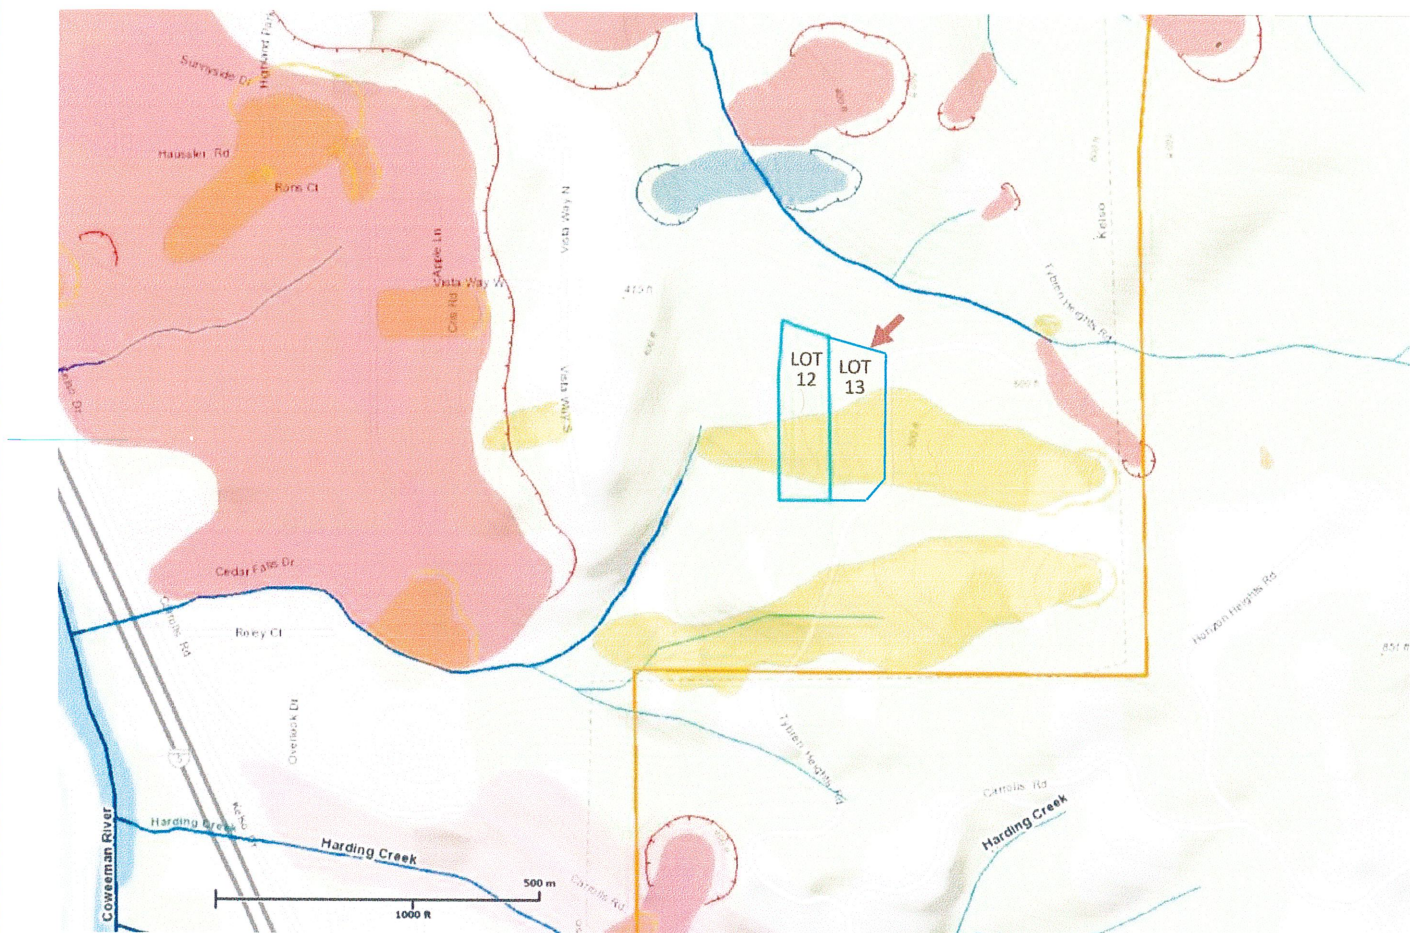
FIGURE
 1

The southern portion of the parcel is mapped within what is mapped as “active, deep seated landslide”, as depicted in Figure 1, based on the WA-DNR landslide inventory publication (Wegmann¹). Therefore, per City of Kelso development codes, a geotechnical report is required to be completed as part of the building and site development application. In preparation of this report, STRATA conducted a field reconnaissance and studied relevant geologic maps, roadside cut slope features, and observed backhoe excavated test holes.

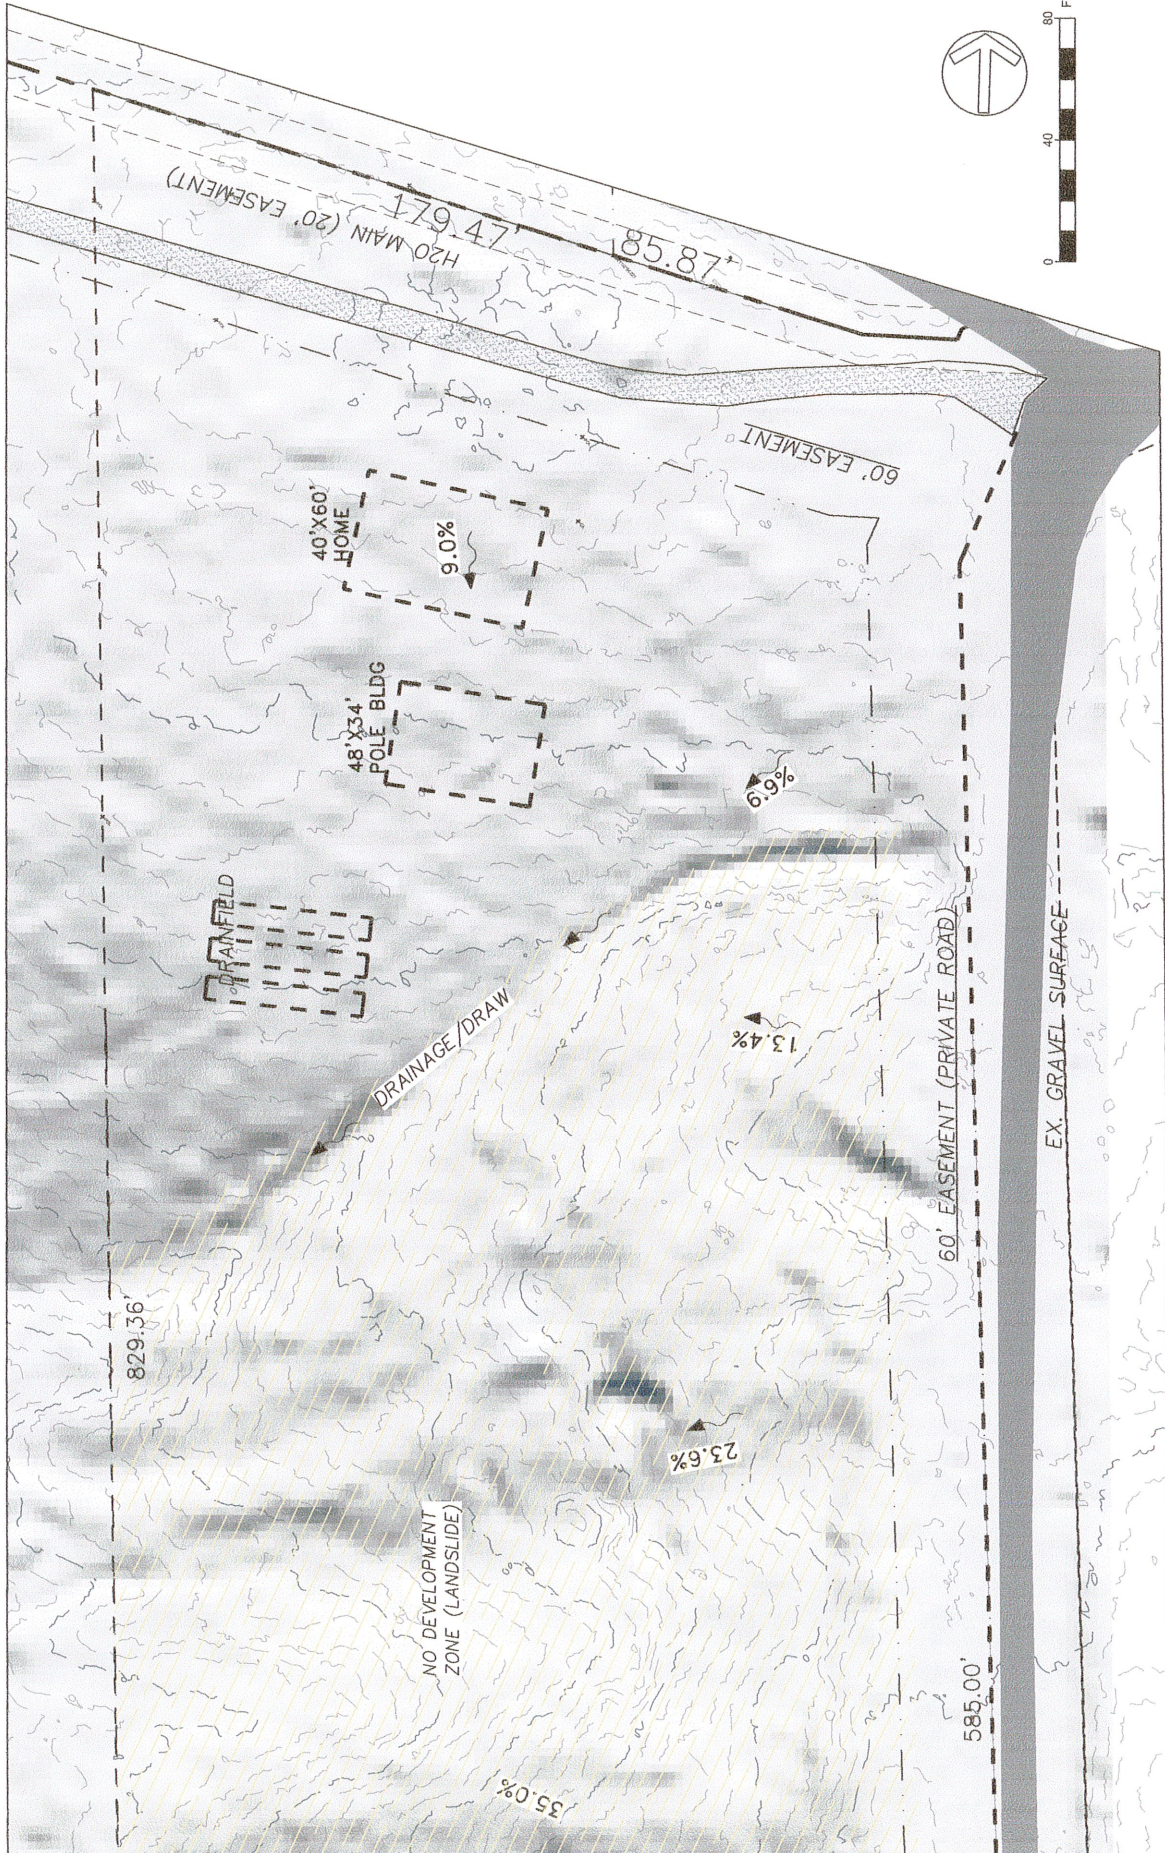
The undersigned professional completed a reconnaissance of the study site to observe all potential geologic or landslide hazards that may be associated with the proposed site improvements. Work consisted of traversing the site and the nearby vicinity of about 200 feet or more each direction from the proposed grading areas. In addition, we evaluated the surrounding terrain utilizing our map of 2-foot elevation contours created from LiDAR point cloud data obtained by the DNR in 2016 (see Figure 2, attached).

We did not observe patterns of irregular and/or hummocky ground or structural evidence of landslide activity within the proposed development zone, or near 50 feet buffer. As shown in Figure 2, the development zone is defined as the topography to the north of the distinct drainage draw that flows east to west/southwest across the lot. Based on our reconnaissance, the subsurface soils exhibit relatively stiff consistency (suitable for structure placement). Within soil test pits, we did not observe soil unit contacts between units that would appear to act as slip planes or seepage pathways.

Given that the proposed development impacts are limited to the upland, low relief portions of the property (Figure 2), we believe, the proposed development can be carried forth per these recommendations in a manner of maintaining overall slope stability and minimizing soil erosion loss. Outside of the limited area of grading and structure development shown in Figure 2, we advise the protecting the native topographic conditions of the site. To promote stormwater dispersion across the slope areas, exposed bare soil areas should be re-seeded with native grass mixes, and/or riparian (woodland) seed mixes.
