Huntington Middle School Modernization

Cultural Resource Survey

**CULTURAL RESOURCE SURVEY FOR THE
HUNTINGTON MIDDLE SCHOOL PROJECT,
KELSO, COWLITZ COUNTY, WASHINGTON**

REPORT NO. 4372

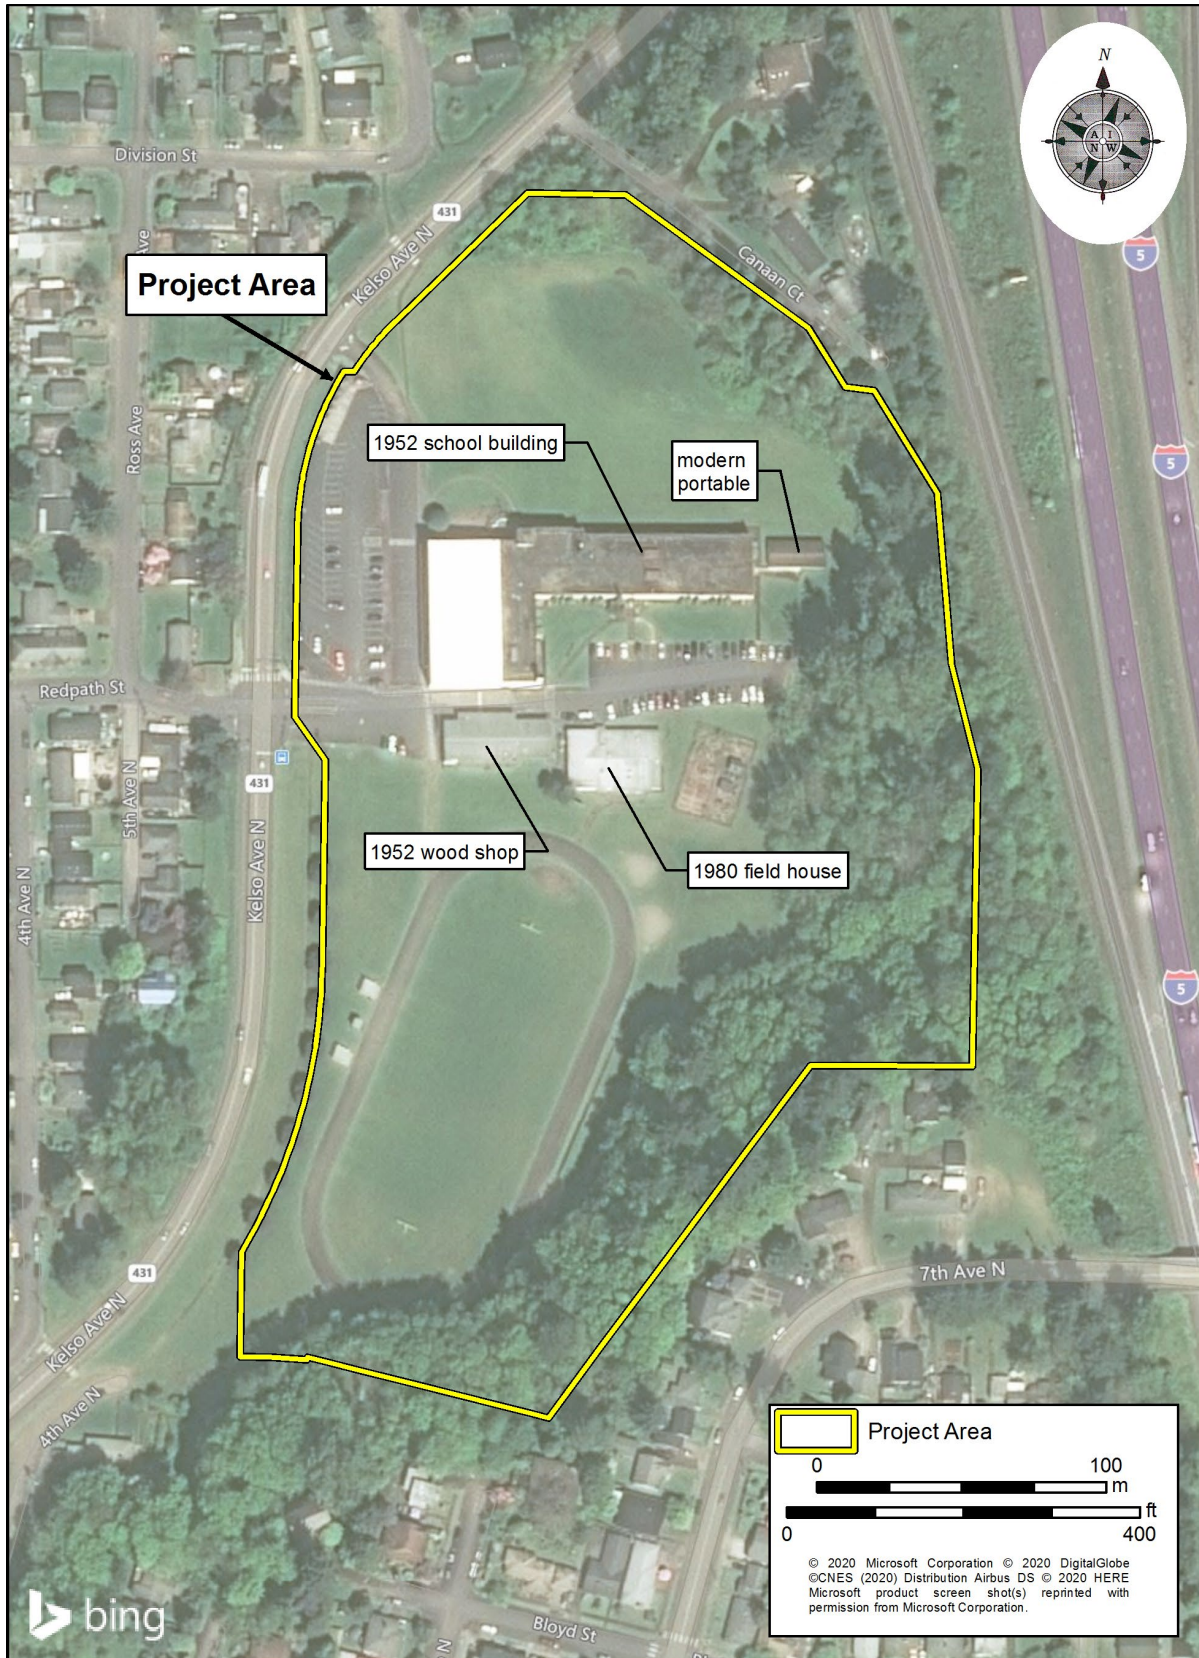
Figure 4. The Huntington Middle School project area showing the locations of historic-period and modern buildings. The 1952 school building and wood shop, 1980 field house, and modern portable are recommended to be not eligible for listing in the NRHP.

The AINW survey identified one historic resource, Huntington Middle School. Alterations to the building and overall school campus have diminished its integrity for the purposes of NRHP eligibility evaluation. The building is recommended to be not eligible for listing in the NRHP, either individually or as part of a potential historic district. The location of the resource, along with outbuildings and landscape features, is shown on Figure 4.

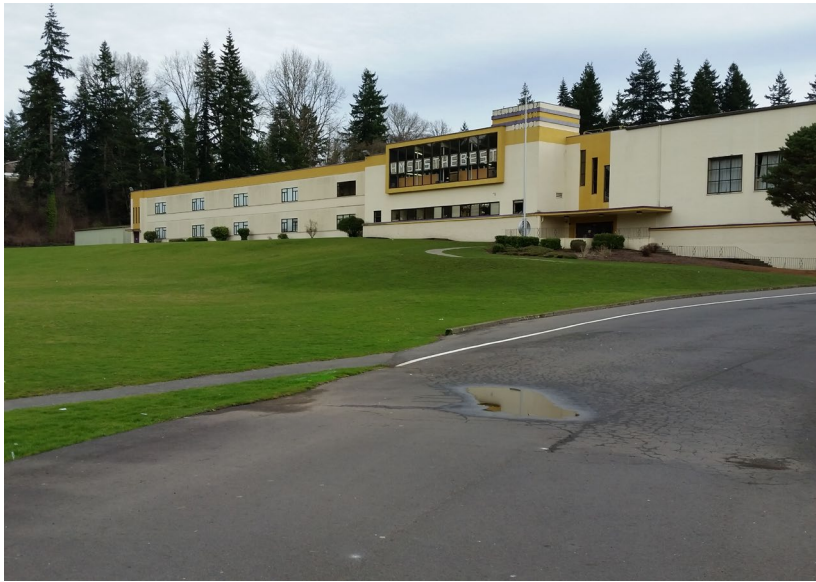
Photo 1. Huntington Middle School is constructed on a fill platform above the natural landform. The main parking lot is in the foreground at right (southwest). The view is towards the southeast.

AINW completed the pedestrian survey of the survey area by walking transects spaced no more than 10 m (33 ft) apart (Figure 2). The Huntington Middle School buildings are built on a fill platform above the natural landform (Photo 1). Three outbuildings (a portable building, the shop room, and the field house) and a school garden are located east and south of the main building (Photo 2). Areas around the buildings are landscaped and contain underground utilities (Photos 3 and 4).

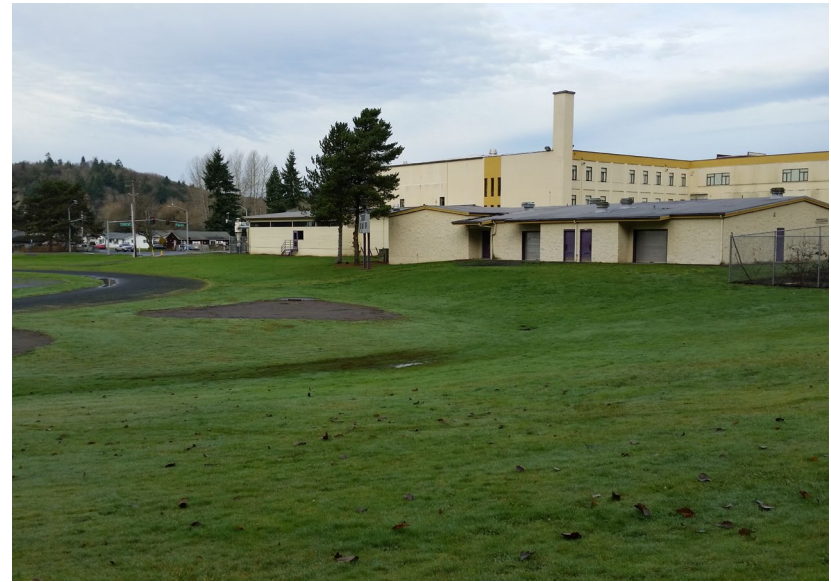
Photo 2. The rear of the school showing the shop building, the field house, and the school garden built on the fill platform. Sewer lines follow the base of the slopes. The view is towards the west-northwest.

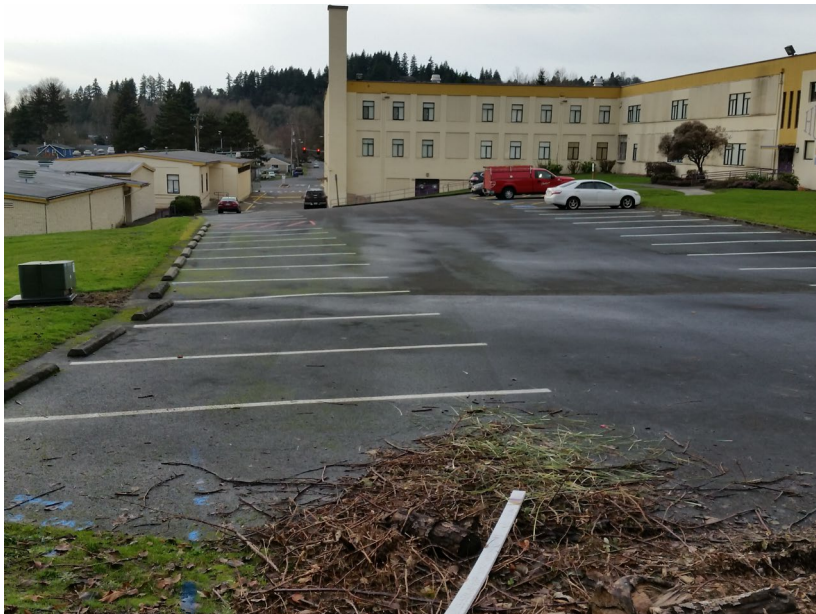
Photo 3. Areas immediately adjacent to the school buildings have been landscaped and contain underground utilities. The view is towards the west.

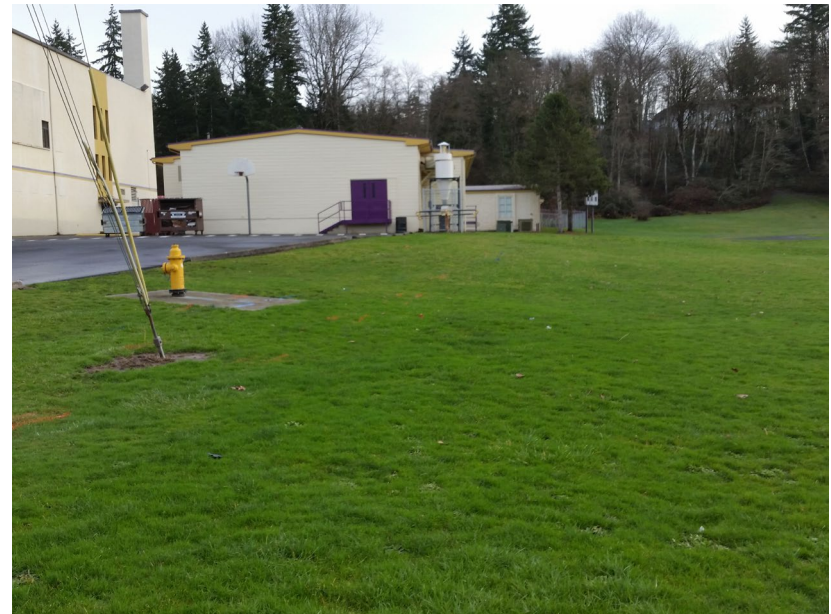
Photo 4. Underground utilities extend throughout the base of the fill platform south of the school. The view is towards the east.

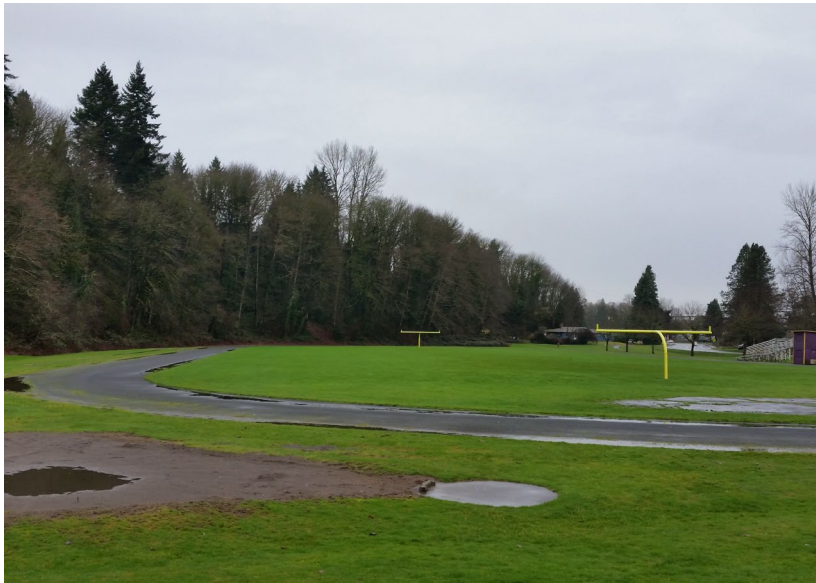
Photo 5. Filling and grading have affected the natural landform in the southern portion of the project area where the athletic field is located. The steep, wooded hillsides are at left (east). The view is towards the south.

An athletic field surrounded by a track is in the southern portion of the project area (Photo 5). Here the natural landform has been leveled through filling and grading. Steep, wooded hillsides surround the school to the east and south. The hills are densely vegetated with Douglas-fir and maple trees and invasive Himalayan blackberry and English ivy. Several ephemeral drainages converge northeast of the track and flow into sewer grates. Areas surrounding the drain grates were saturated at the time of the pedestrian survey.

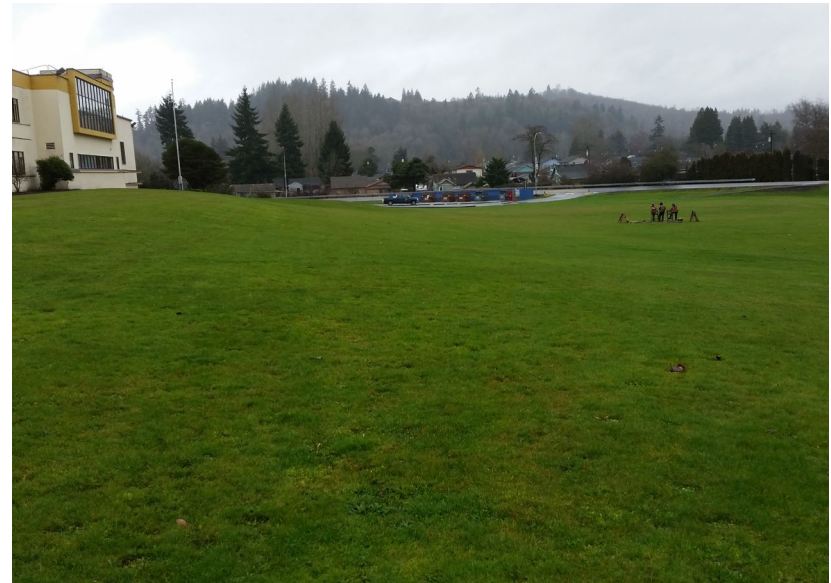
Photo 6. Shovel test ST-3 was excavated north of the fill platform in the northern portion of the project area. The view is towards the east.

AINW excavated five shovel tests (ST-1 through ST-5) in the open field north of the school (Figure 3, Photo 6). Four of these shovel tests (ST-1 through ST-4) were excavated north of the fill platform and encountered a brown silt loam to silty clay loam consistent with the Caples soil series mapped for the majority of the project area (USDA-NRCS 2005). Between 15 and 45 cm (6 and 18 in) below the surface, the soils transitioned to a mottled silty clay loam that had increasing amounts of iron and manganese nodules. A gray silty clay loam was identified at the base of shovel test ST-1, which was augered to a depth of 200 cm (79 in) below the surface. Two shovel tests, ST-1 and ST-4, contained modern debris in the upper 175 cm (69 in) and 40 cm (16 in). Shovel test ST-5 was at the toe of the fill

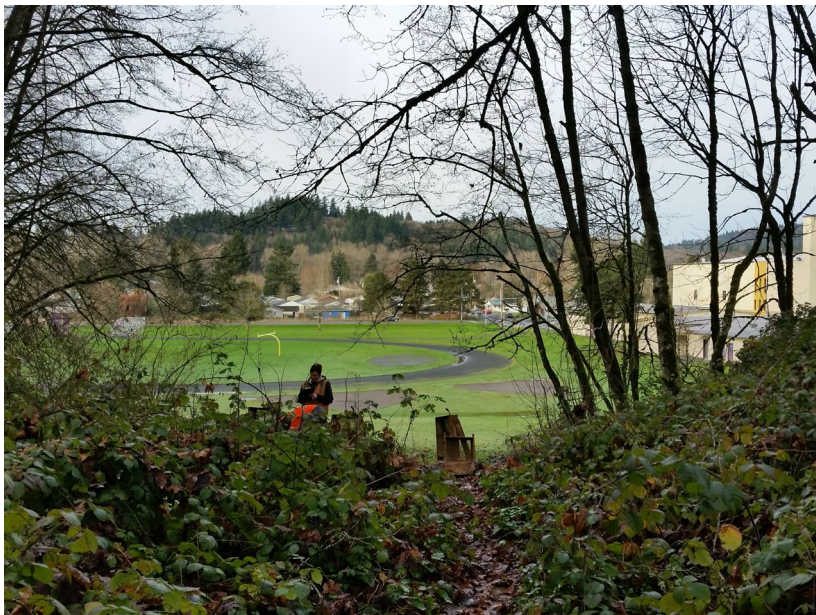
Photo 7. Shovel test ST-8 was excavated on a portion of the wooded hillside with a moderate slope. The athletic field is in the background. The view is towards the west.

AINW excavated four shovel tests (ST-6 through ST-9) on or along the hillsides east of the school (Figure 3; Photo 7). Three of these shovel tests, ST-6, ST-7, and ST-8, encountered a silty loam or silty clay loam consistent with the Kelso soil series. Modern debris was identified in the upper 30 cm (12 in) and 10 cm (4 in) of shovel tests ST-6 and ST-7. Shovel test ST-9 encountered a mottled gravelly silt loam

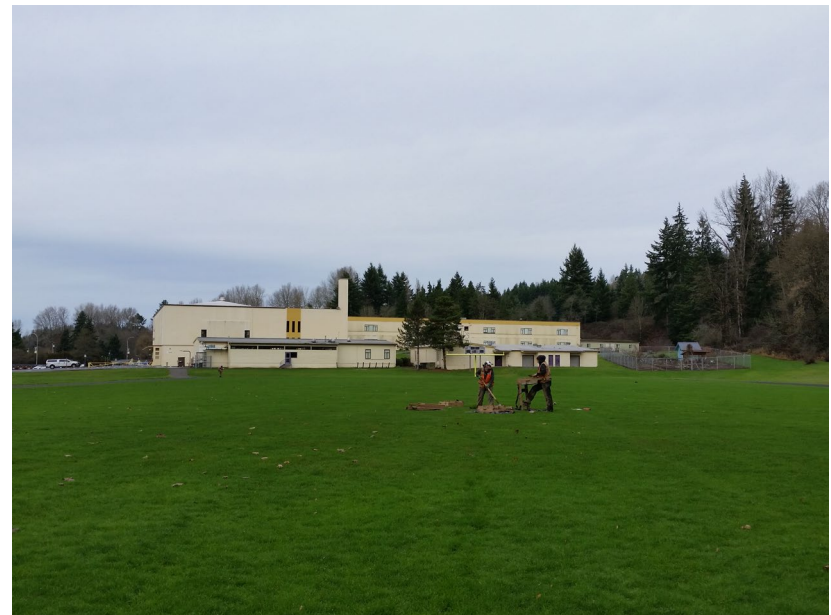
Photo 8. Fill and modern debris were encountered in the upper 25 cm (10 in) of shovel test ST-14, shown in progress within the athletic field . The view is towards the north.

Seven shovel tests (ST-10 through ST-16) were excavated within and near the athletic field (Figure 3; Photo 8). Between 25 and 65 cm (10 and 26 in) of sandy fill was identified in five of these shovel tests (ST-10, and ST-12 through ST-15). A brown silt loam to silty clay loam consistent with the Caples series was identified under the fill layer (USDA-NRCS 2005). Only two shovel tests, ST-11 and ST-15, did not exhibit evidence of previous ground disturbance; in these, intact soil consistent with the Caples soil series was observed.

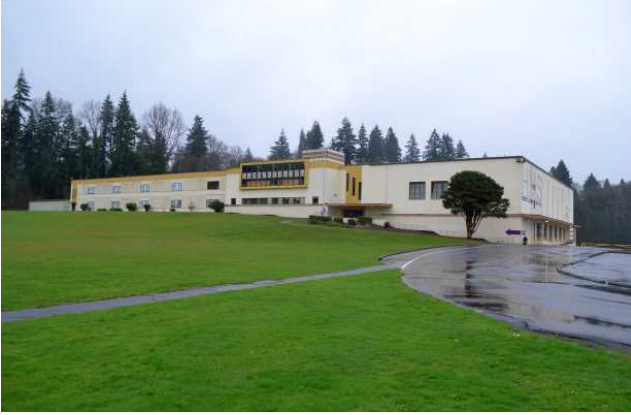
North (primary) and west elevations, facing southeast

The middle school is a two-story building with an L-shaped footprint standing on a poured concrete foundation with a daylight basement. The school building's exterior walls are constructed of poured concrete coated in stucco with Roman brick ornamentation on the north (primary) facade. In-filled exterior wall space originally taken up by windows is ornamented with vertically-scored stucco. The school building has a flat roof with a parapet clad in rubber roofing membrane, and a chimney is in the southeast corner of the south wing (Kelso School District 2017). The building is accessed on each elevation by double-doors under flat concrete awnings. The gymnasium and cafeteria are located on the west side of the west wing, the administrative and library block are approximately central to the north wing, and the rest of the building is dedicated to classroom space.

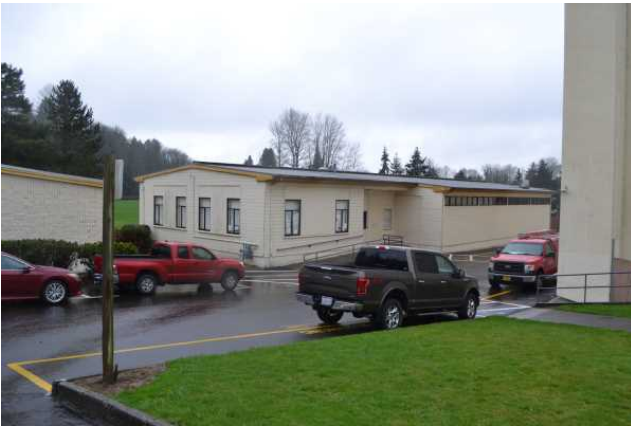
Wood shop north (primary) and east elevations, facing southwest

The wood shop building was constructed in association with the junior high school in 1952. The shop is a one-story building with a T-shaped footprint resting on a poured concrete foundation located directly south of the primary building. The building has a side-gable roof, horizontal wood lap siding, historic-period wood-and-glass doors, and retrofitted anodized aluminum windows. The classroom, storage area, restroom, and hallway have vinyl tile flooring, sheetrock walls, and historic-period acoustical ceiling tiles. Built-ins in the classroom and storage area are identical to those in the main building. The shop room has cement flooring, modern suspended fluorescent lighting, and walls are a mix of sheetrock and horizontal wood board. A historic-period enameled sink is on the east wall of the shop, but all other counters, ductwork, and equipment appear to be modern.

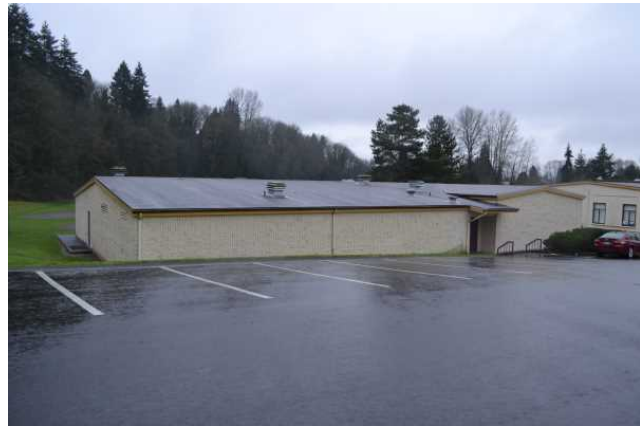
Field house north and east elevations, facing southwest

The field house was constructed south of the primary building and east of the woodshop in 1980. It is a one-story building with a roughly rectangular footprint resting on a poured concrete foundation. The building has a cross-gabled roof, anodized aluminum windows, aluminum doors, and is constructed of split-rib concrete masonry units (CMU).
