CRITICAL AREAS REPORT

January 20, 2022

*Segale Properties Site
Kelso, Washington*

Prepared by
Ecological Land Services, Inc.
1157 3rd Avenue, Suite 220A • Longview, WA 98632
(360) 578-1371 • Project Number 3665.02

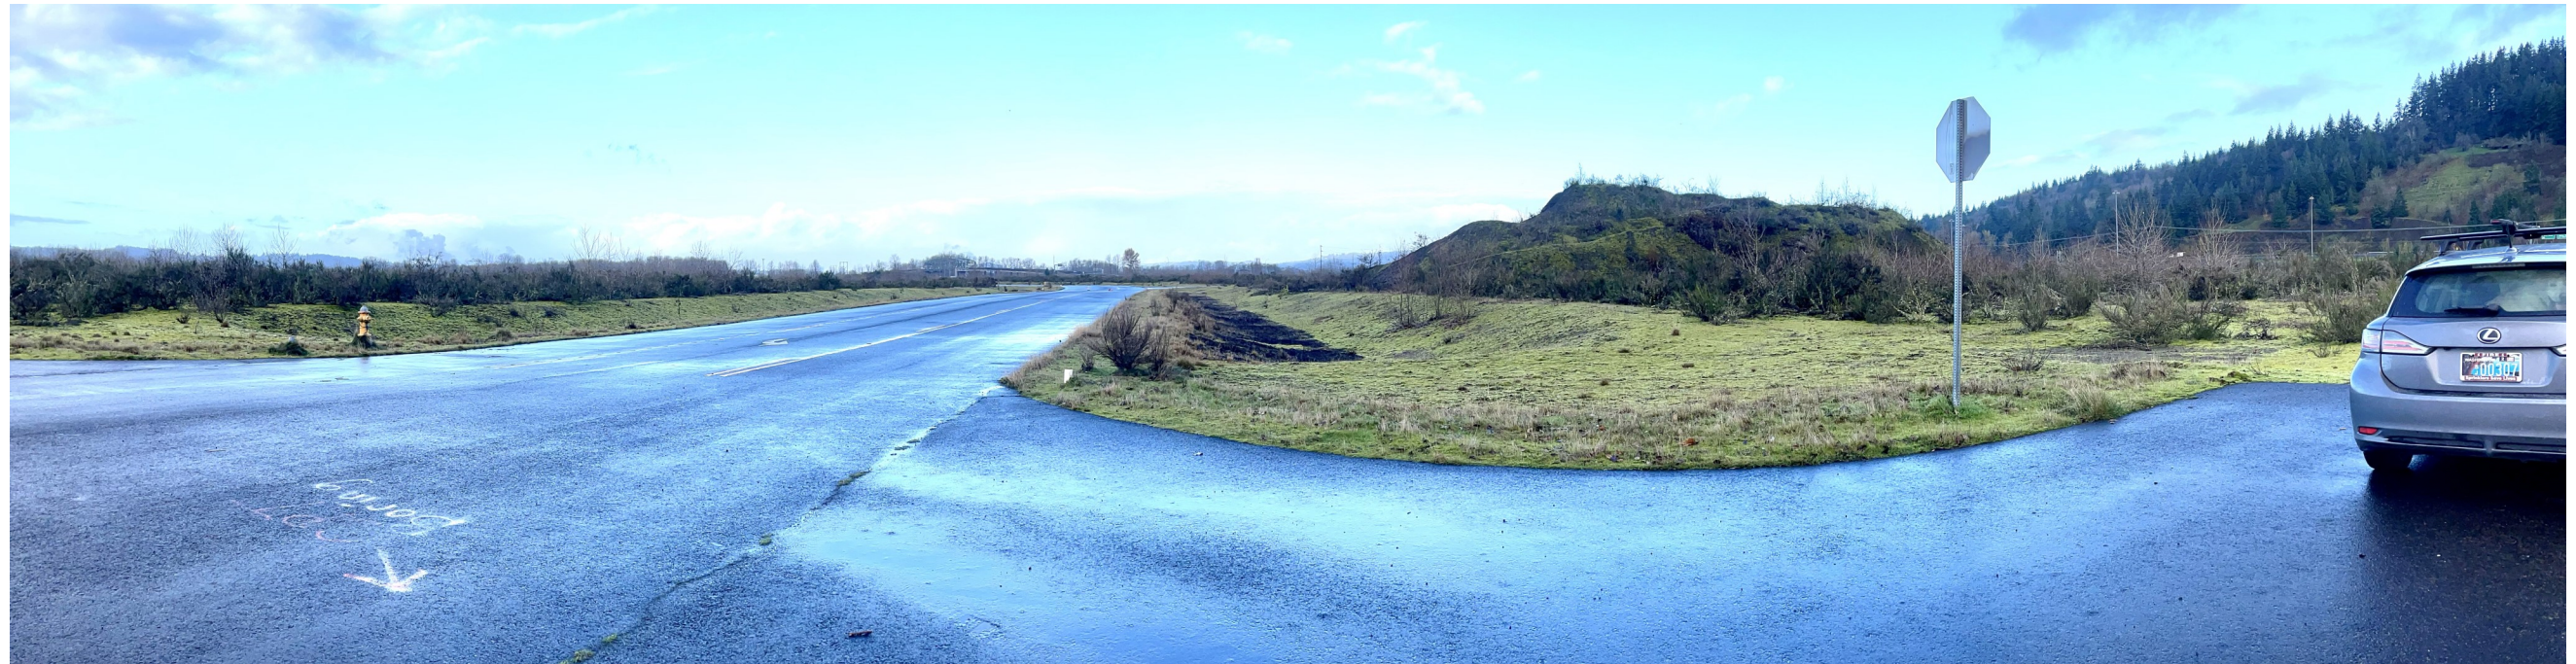
Photo 1: Southern end of Talley Way facing north in the central portion of the study area.

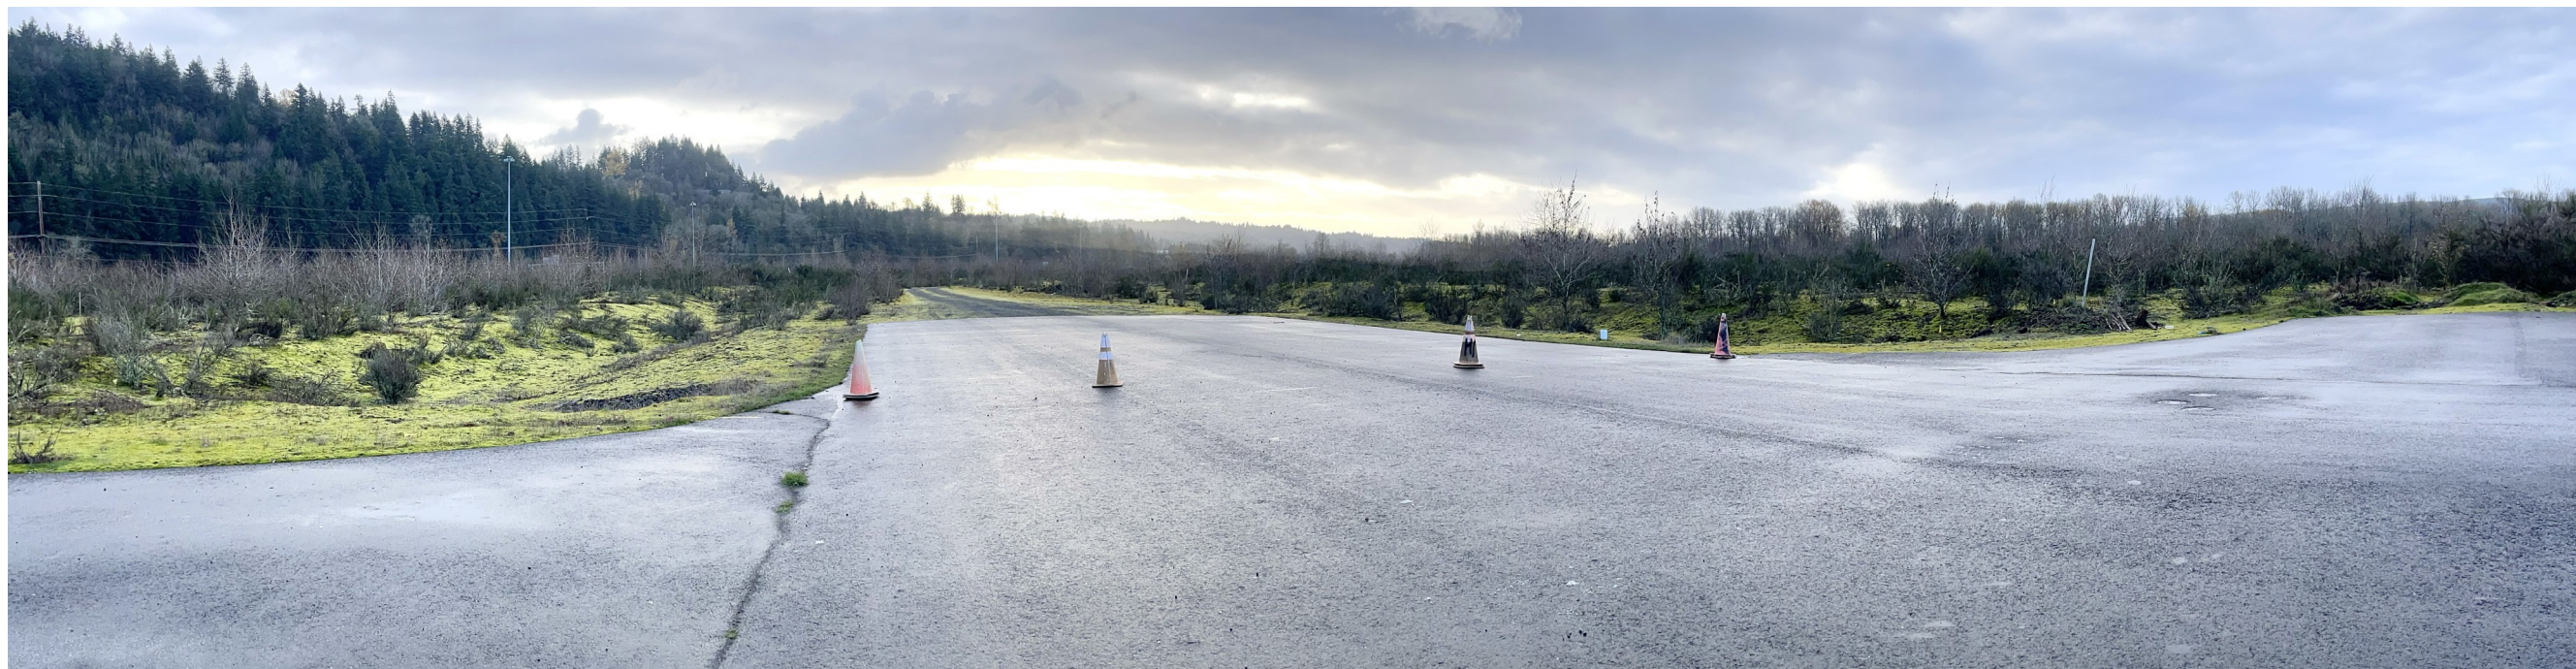
Photo 2: Southern end of Talley Way facing south in the central portion of the study area.

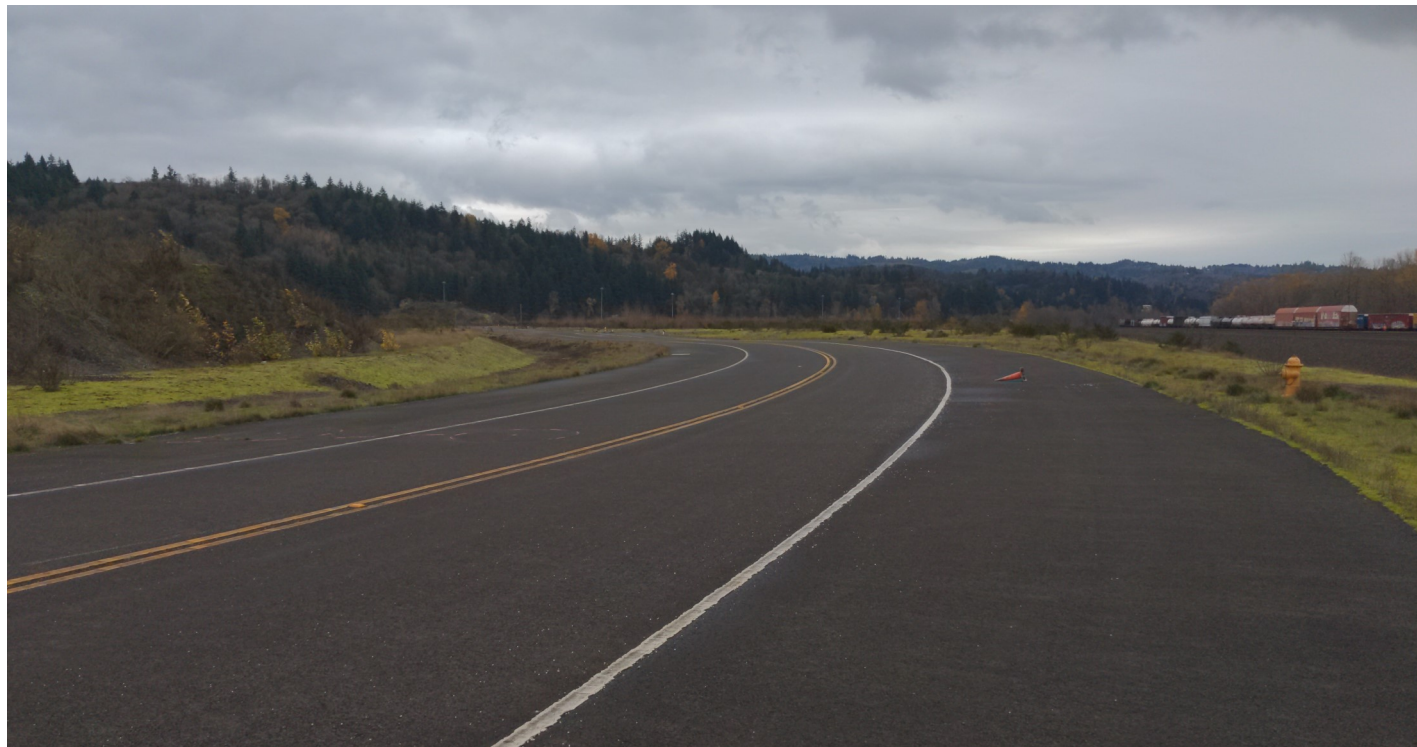
Photo 3: Northern end of Talley Way facing south at the northern end of the study area.

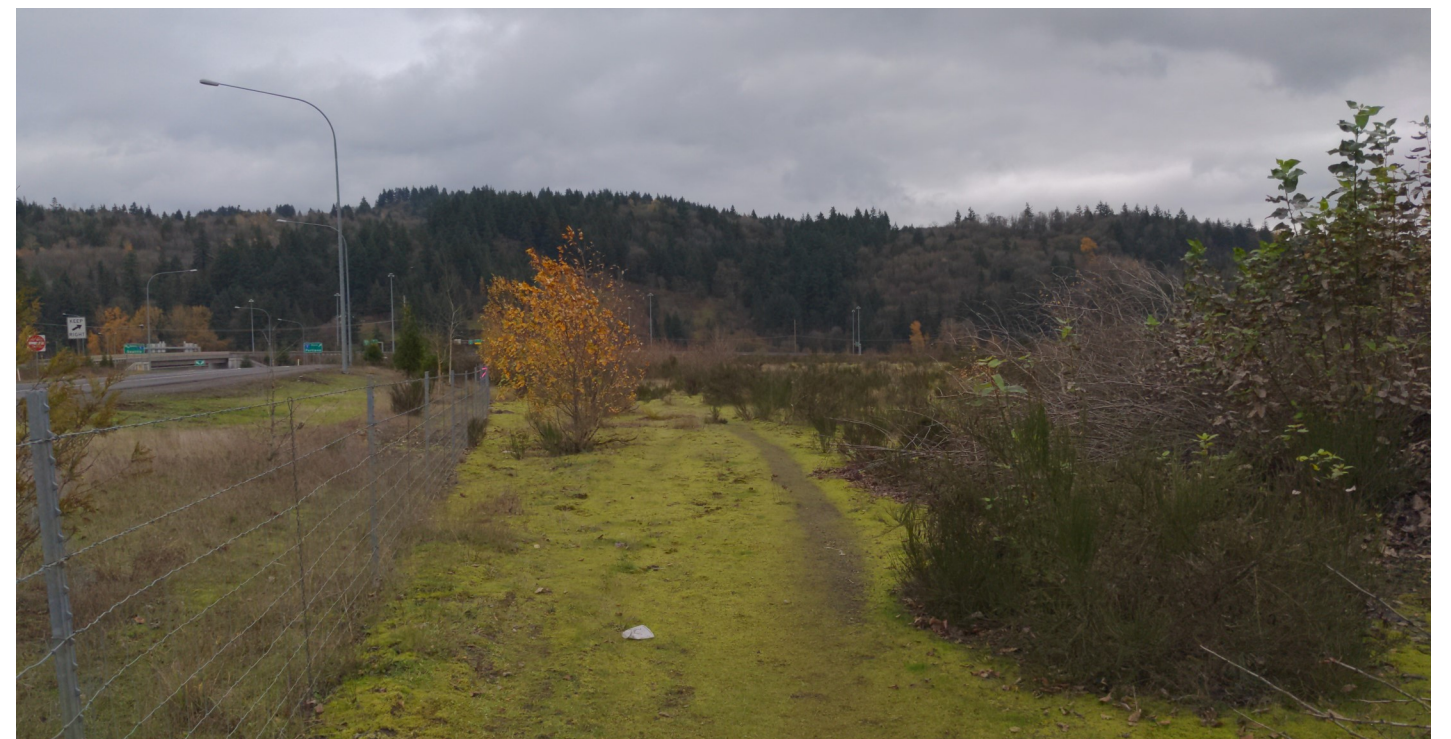
Photo 5: Overall representative upland photo in southern portion of the study area facing southwest. Trees pictured in center right are offsite along a railroad berm.

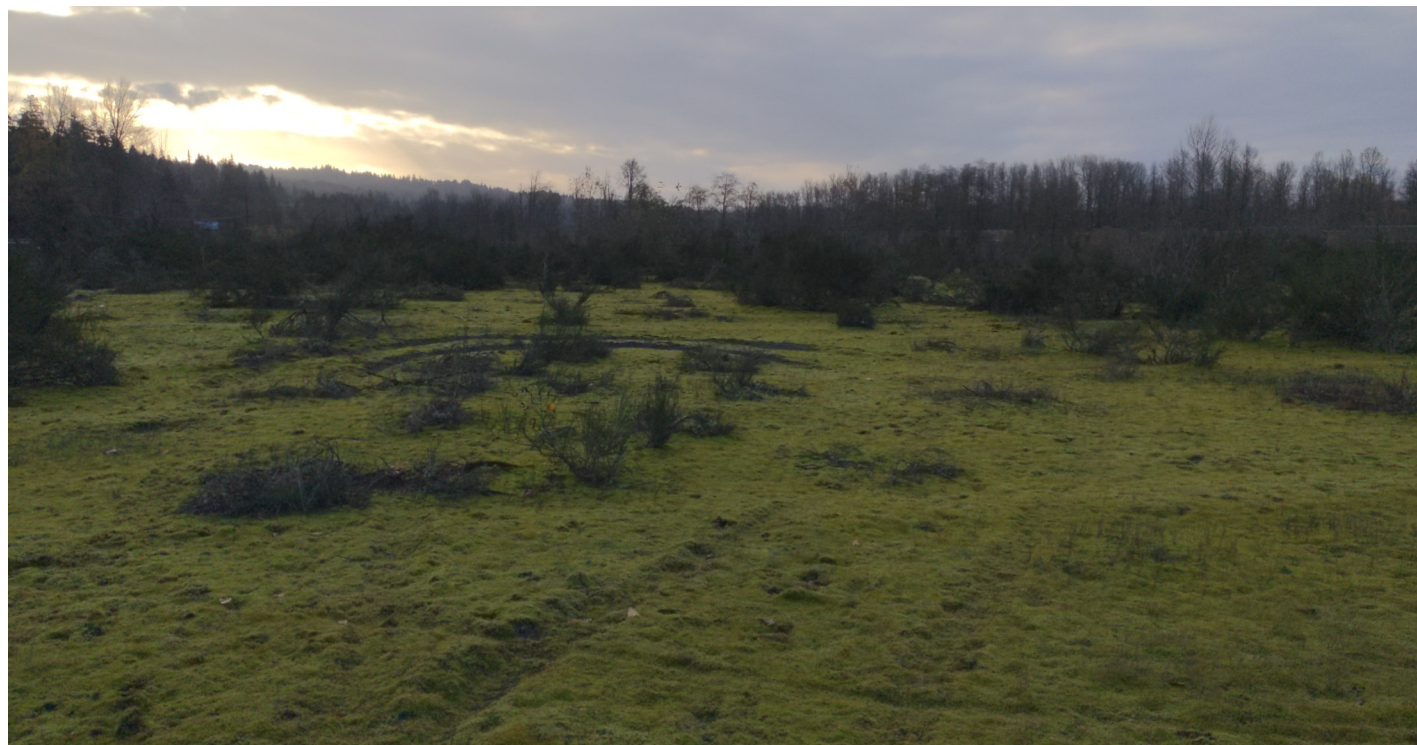
Photo 4: Facing east along northern property line.

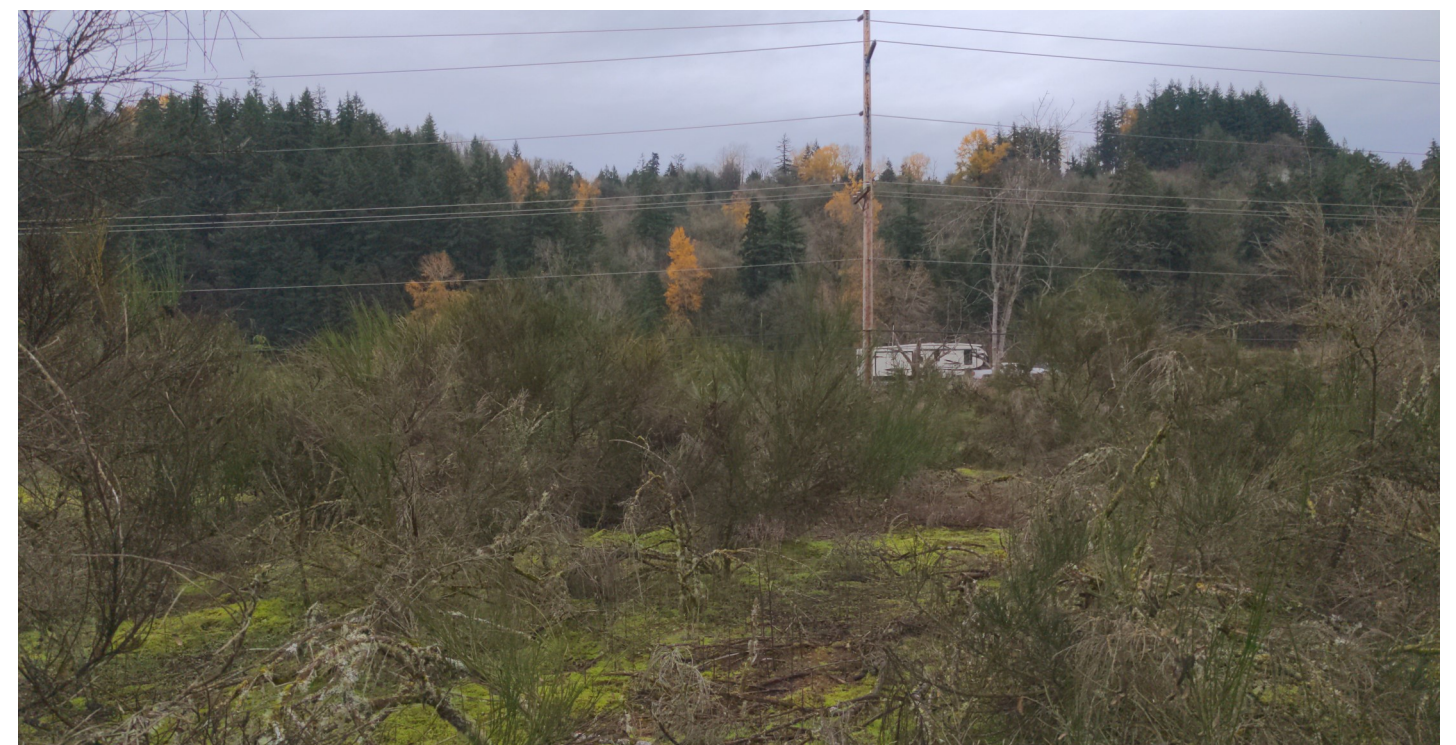
Photo 6a: Facing east in a lower elevation area in the southern end of the study area. Truck and trailer pictured at center are traveling south on I-5 offsite.

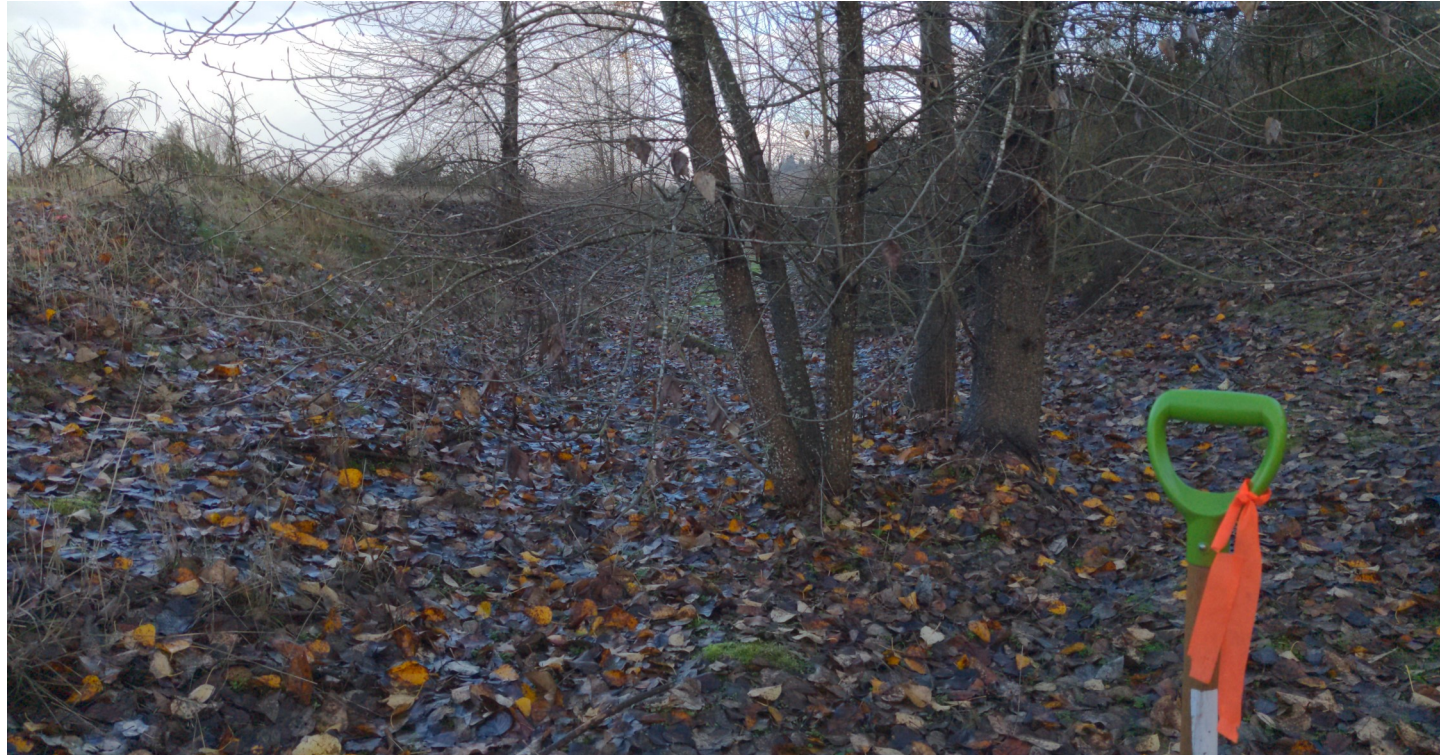
Photo 8: Facing north in the vicinity of TP-1, which was located in a topographically low area in the southeast portion of the study area.

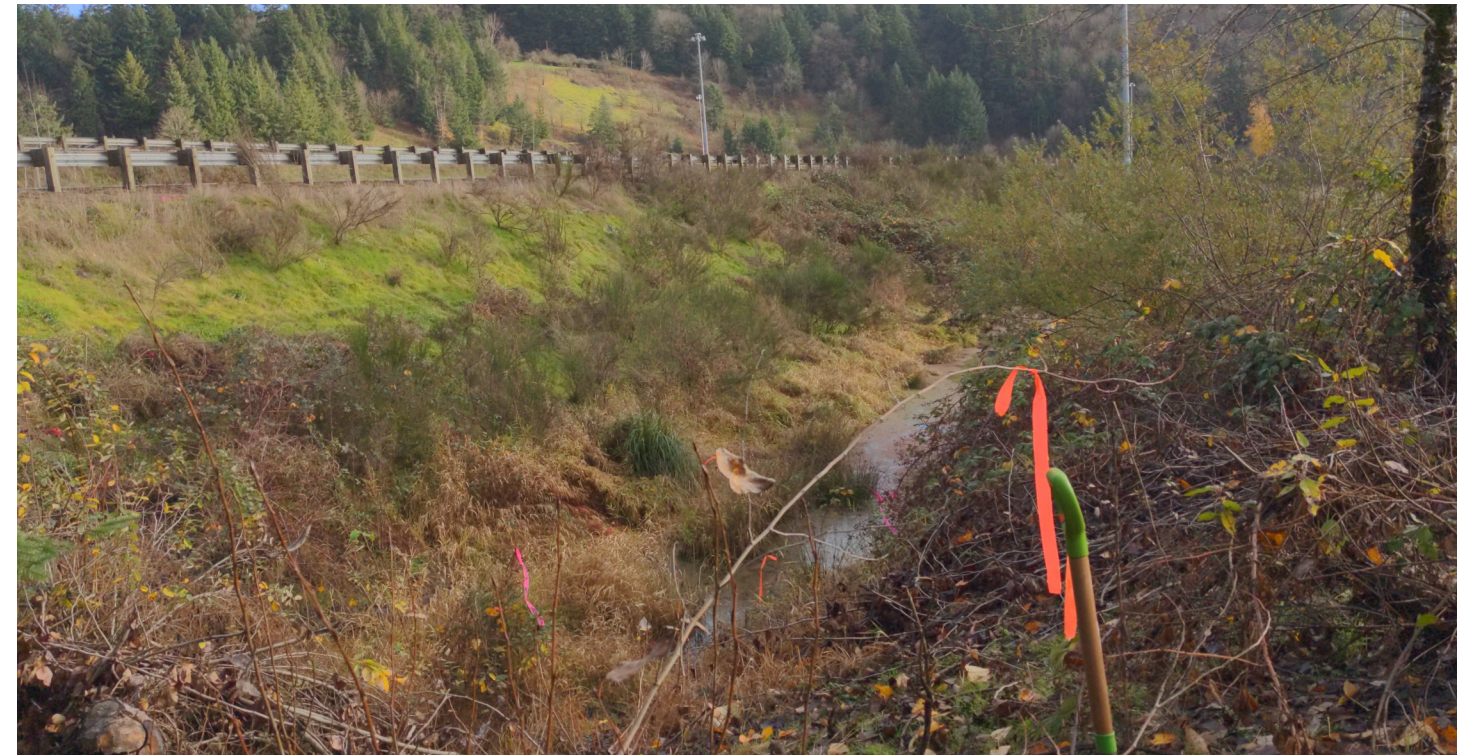
Photo 9: Facing southeast at the northeastern finger of Wetland A. TP-10 is visible in the foreground. TP-9 and a wetland flag are visible downslope.

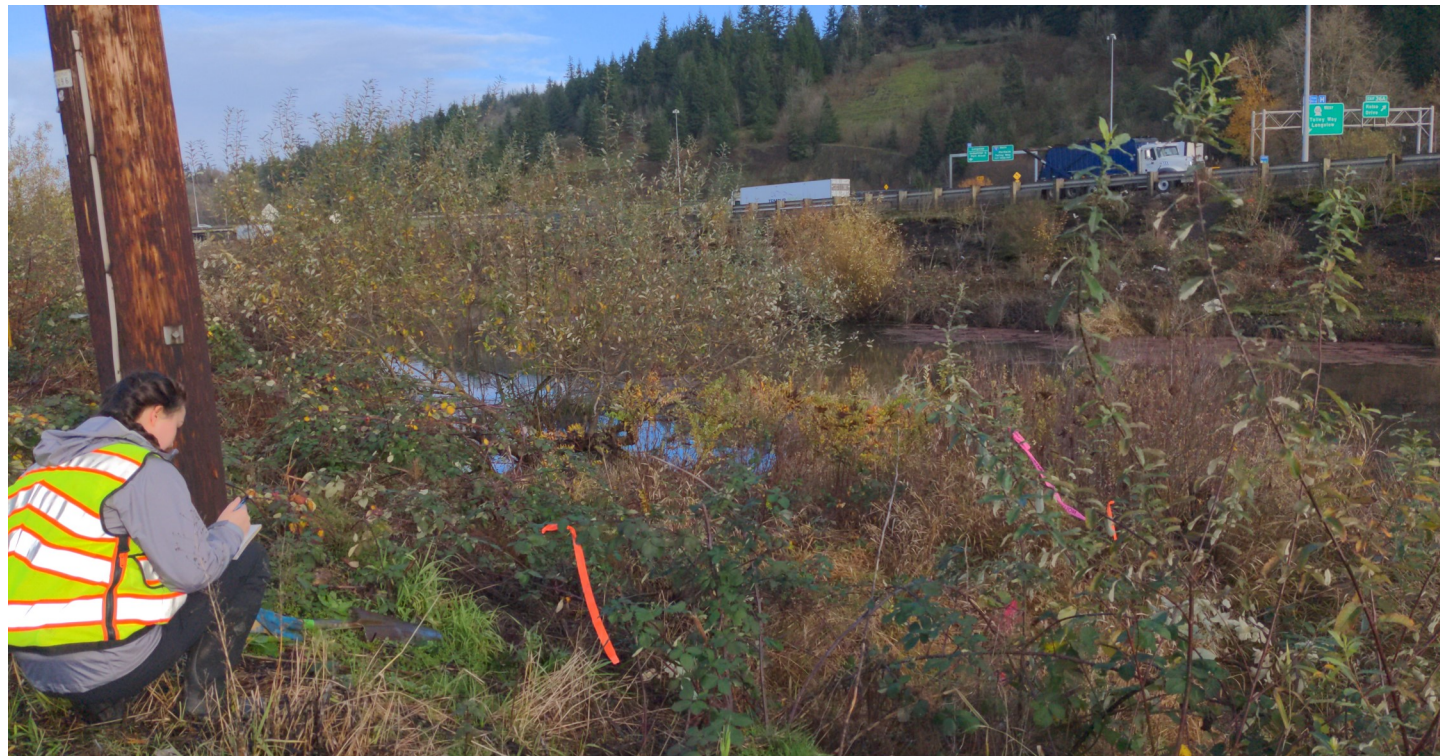
Photo 10a: View looking northeasterly at TP-8 located on the fill slope of the utility pole. The I-5 southbound onramp is visible across the center.

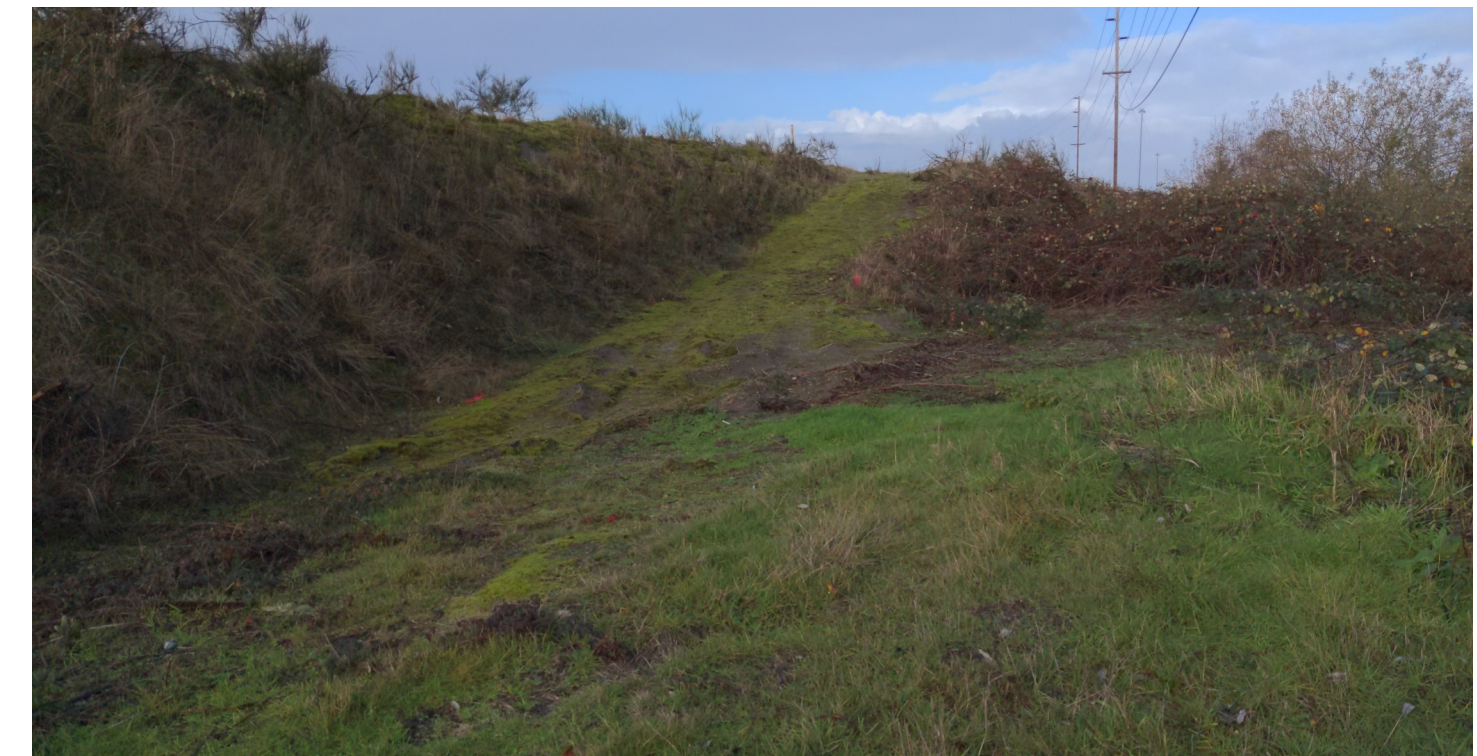
Photo 10b: Looking northerly at the utility access along the eastern portion of the study area in the vicinity of TP-8.

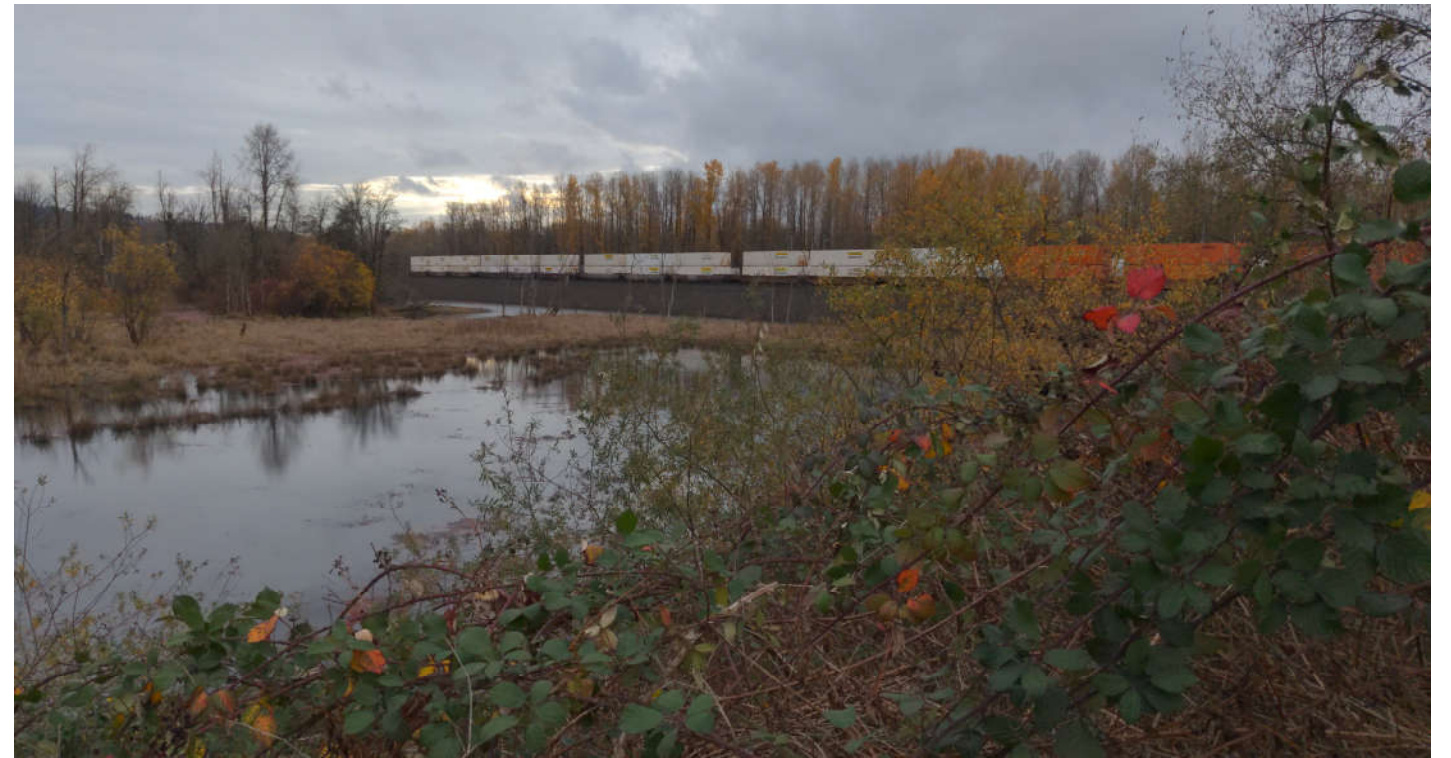
Photo 11b: Facing southwest from the same location as Photo 11a across Wetland A at the southern end of the study area.

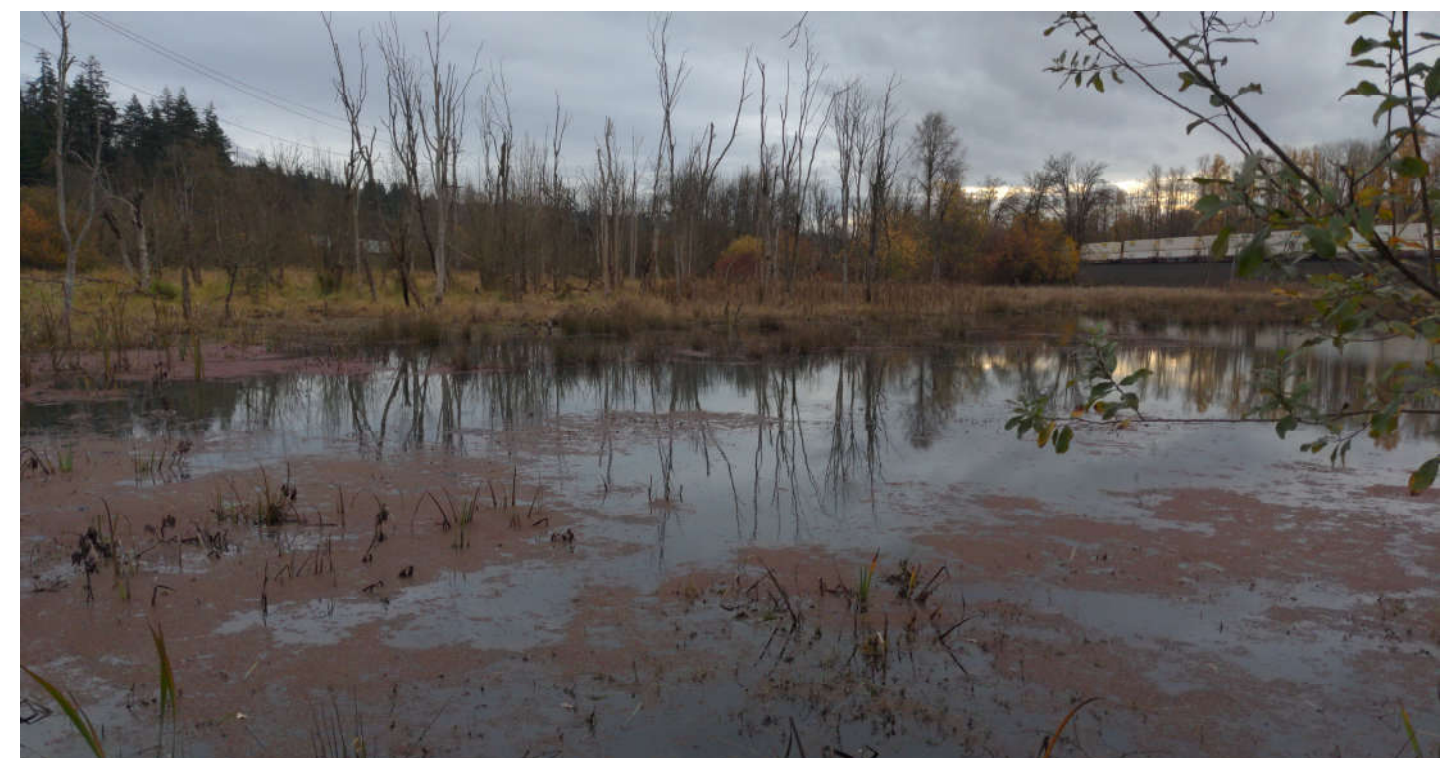
Photo 12b: Facing south across Wetland A from TP-3.

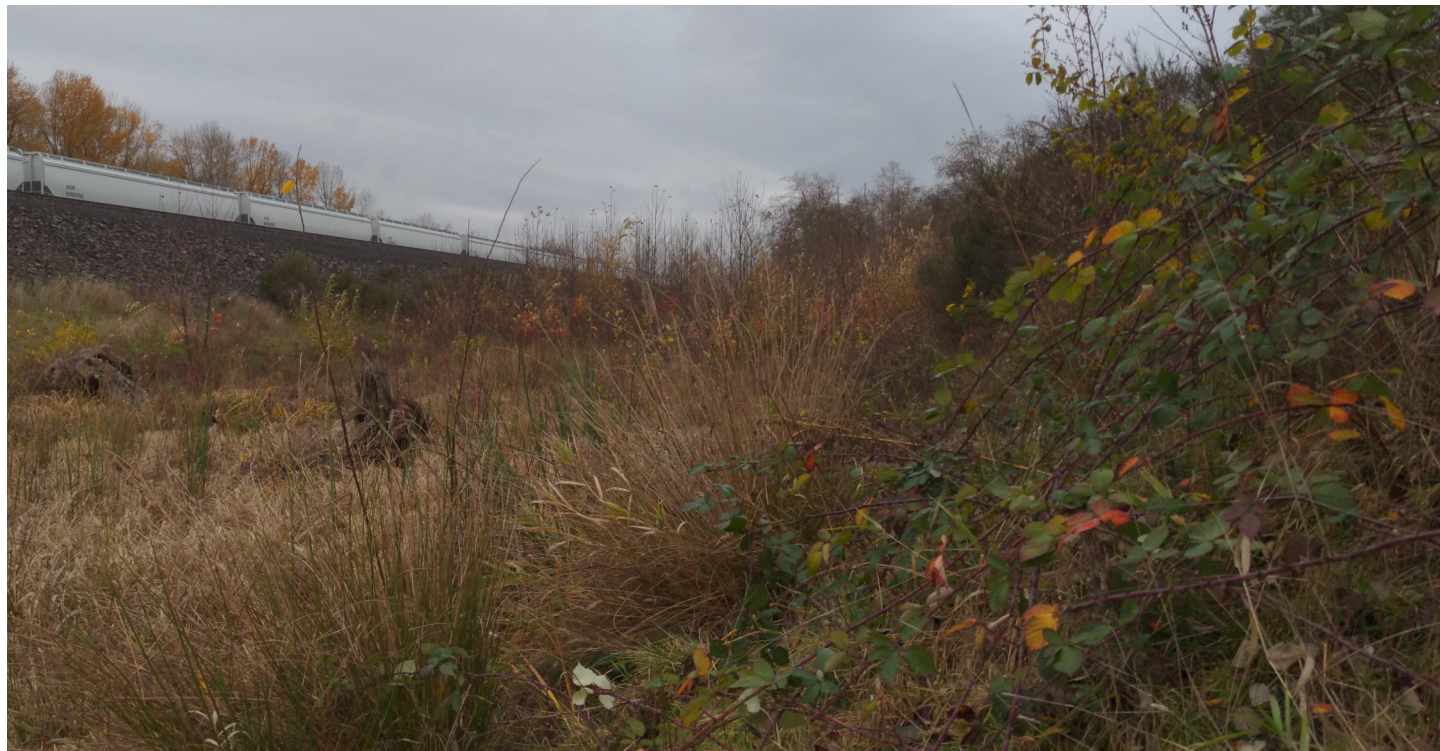
Photo 13: Facing north at the southern end of the western finger of Wetland A. The corner of the fill slope is visible at right.

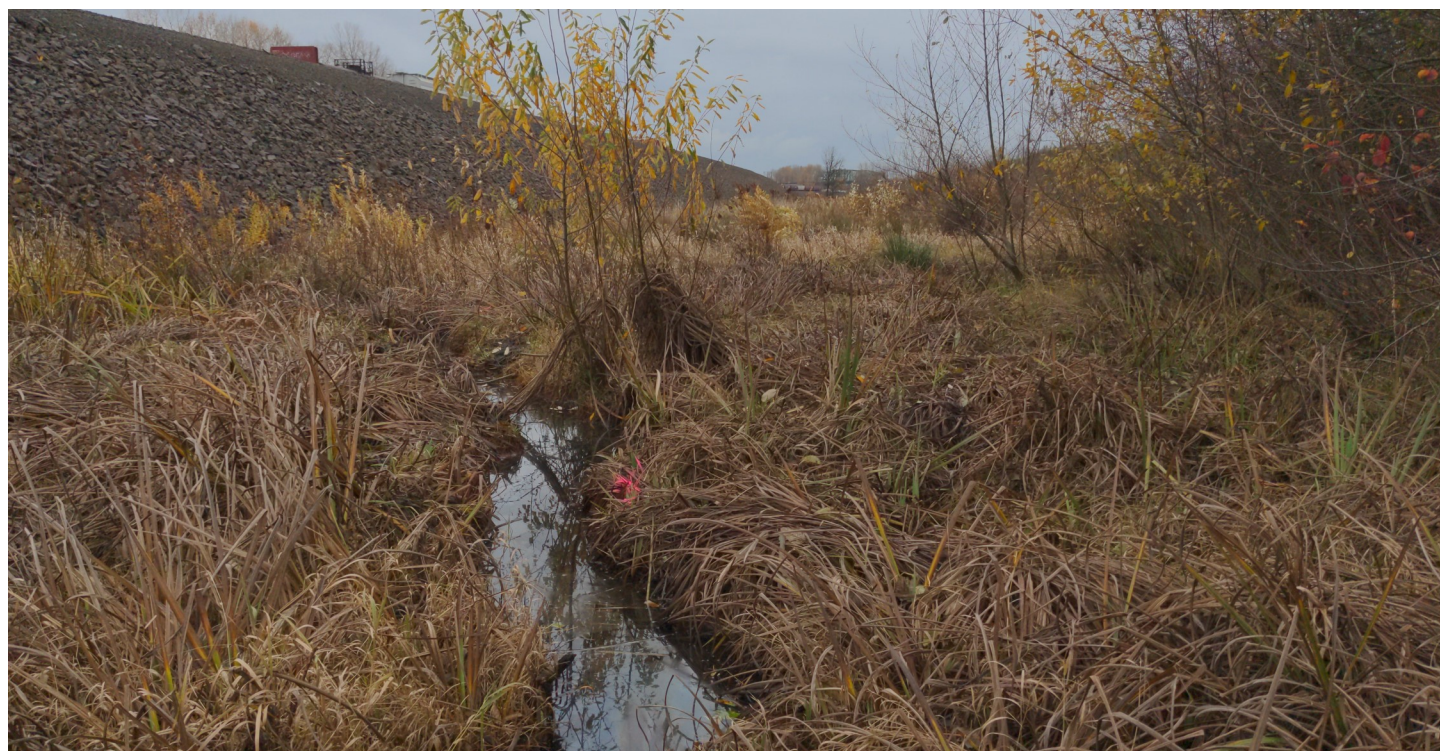
Photo 14: Facing north at the western finger of Wetland A from TP-5. TP-5 is located on fill approximately 4 feet higher than Wetland A.

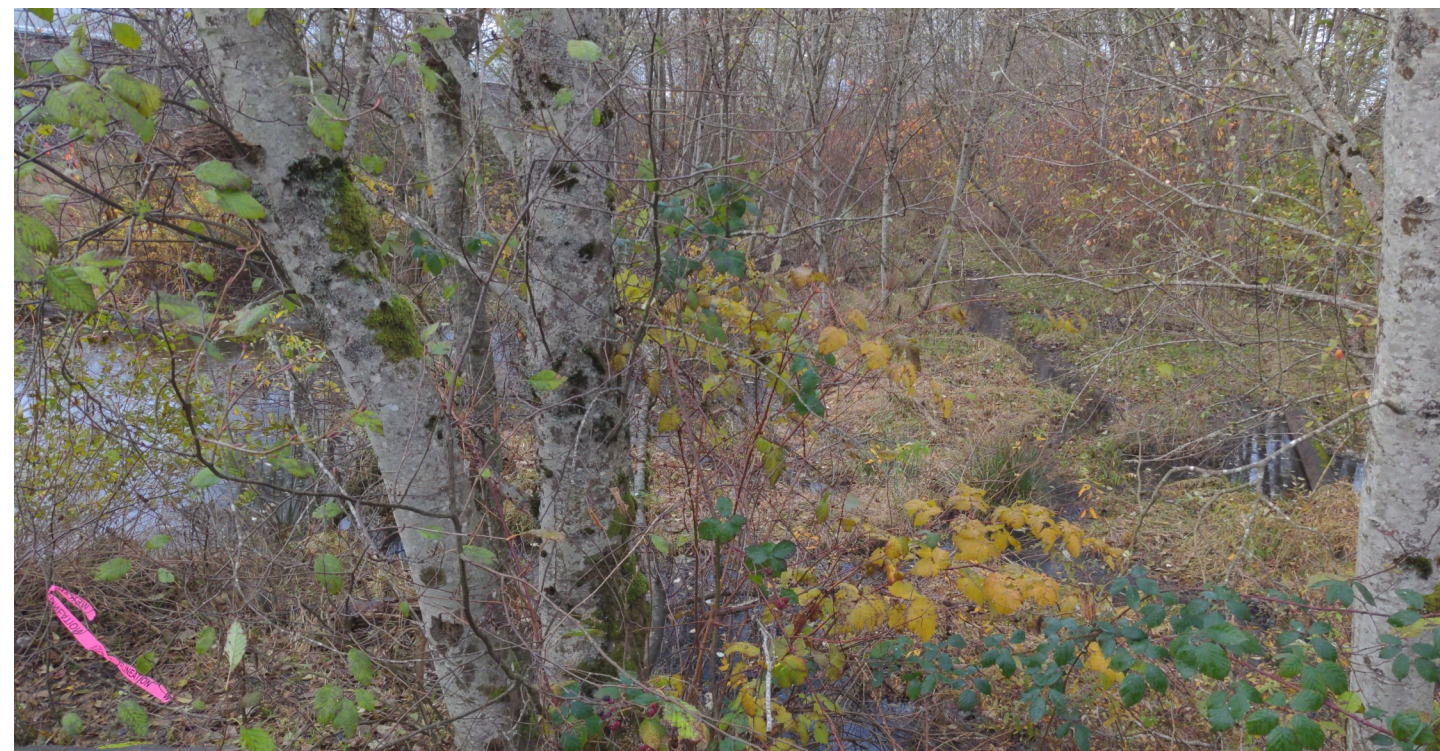
Photo 15: Facing north at the channel that extends through the southern portion of the western finger of Wetland A. This channel may be maintained by beavers.

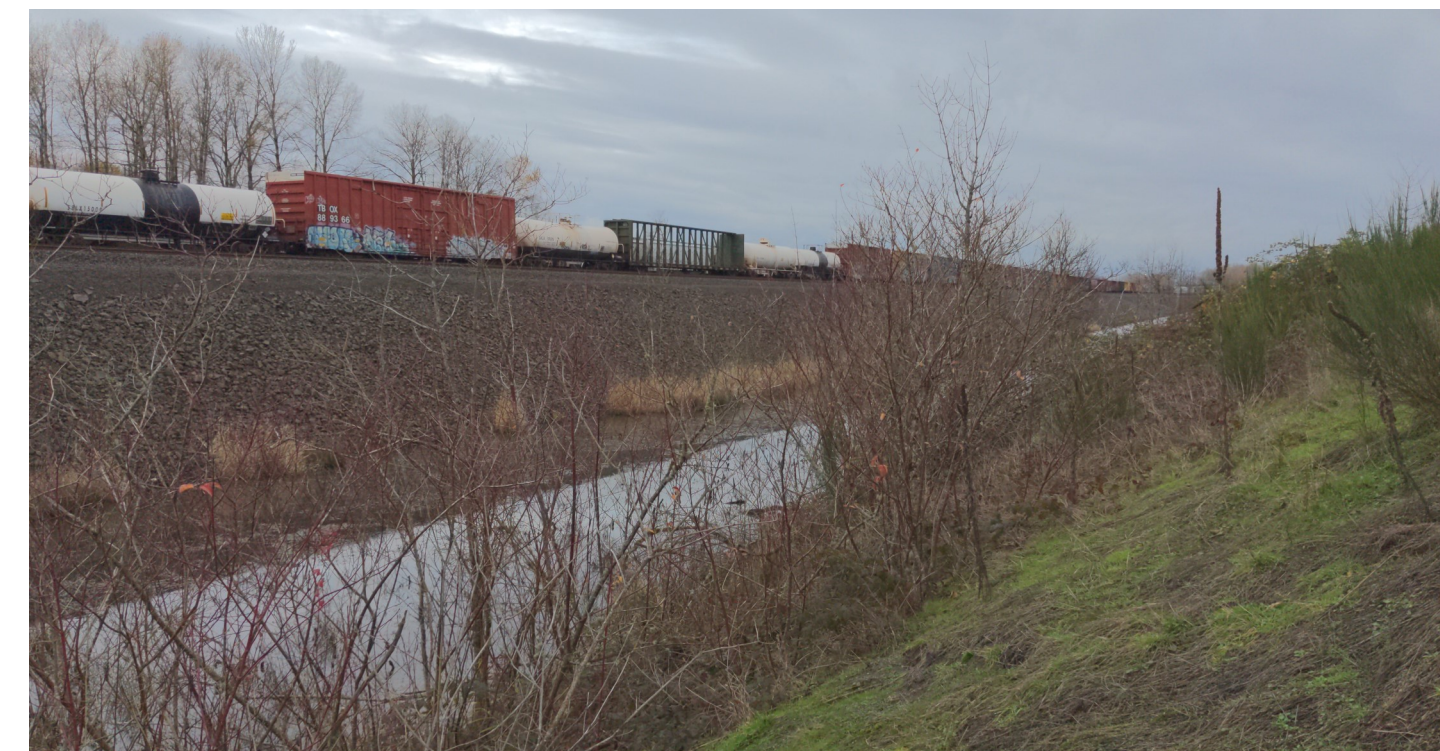
Photo 16: Facing north at the central portion of the western finger of Wetland A that contains permanent water.

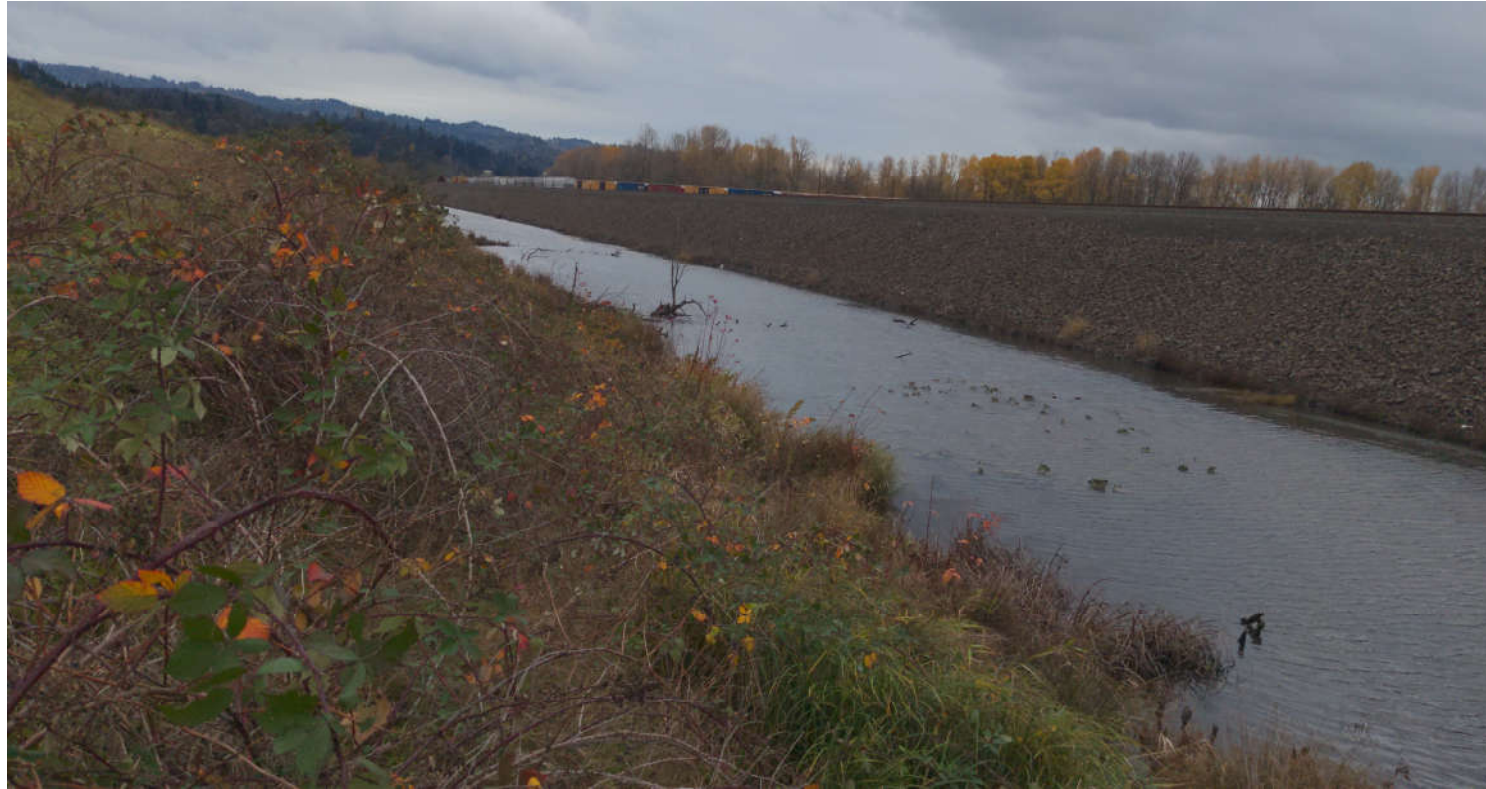
Photo 17a: Facing south from the northern portion of the western finger of Wetland A. Limited vegetation is present on the fill slope.

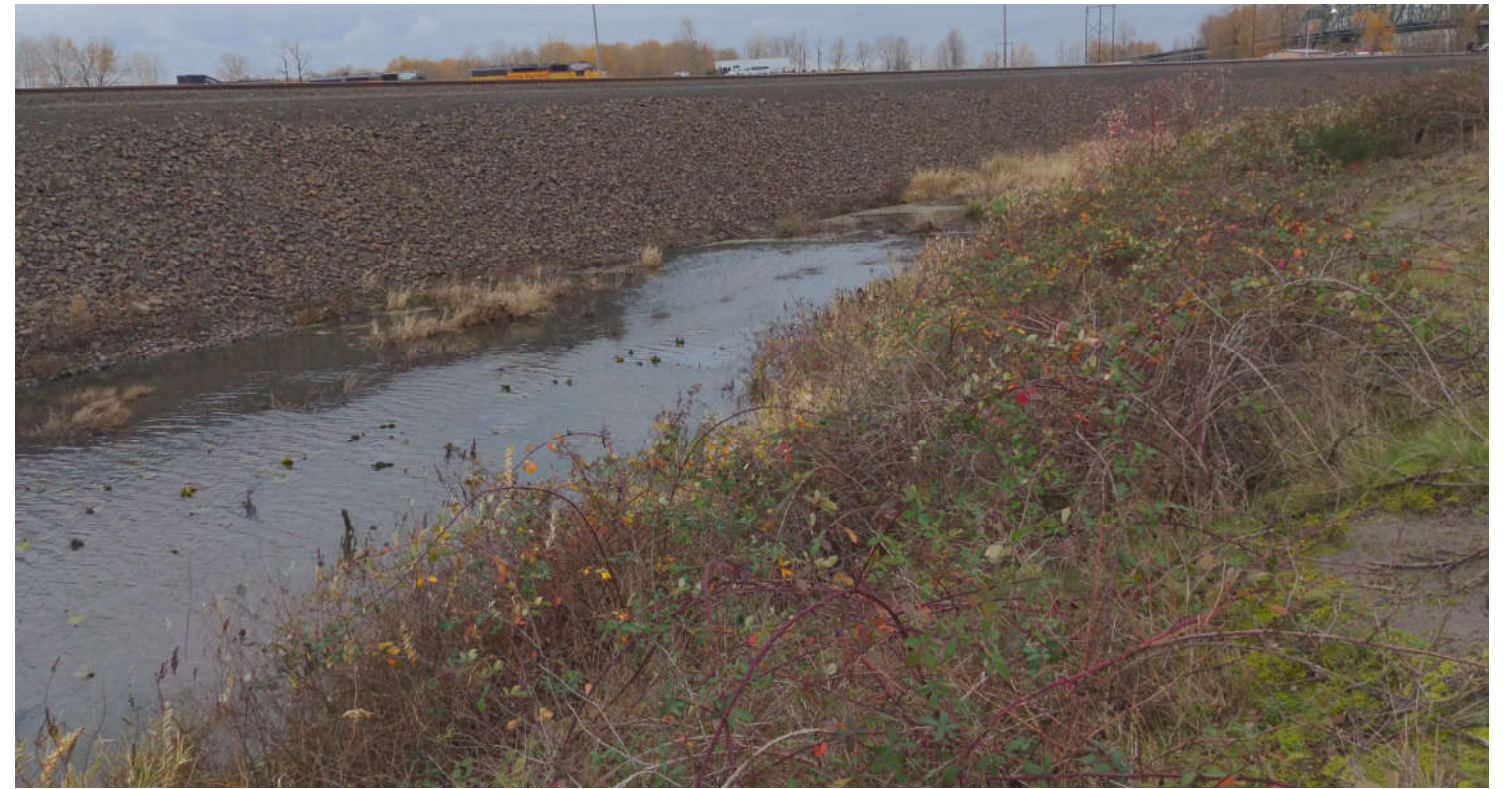
Photo 17b: Facing north from the same location as Photo 17a. Permanent flooding transitions to seasonal flooding near the light brown vegetation pictured in the upper right.
