Tybren Heights Development

Preliminary Drainage and Erosion Control Report

Fuller Designs Project No. 1920

January 26, 2020

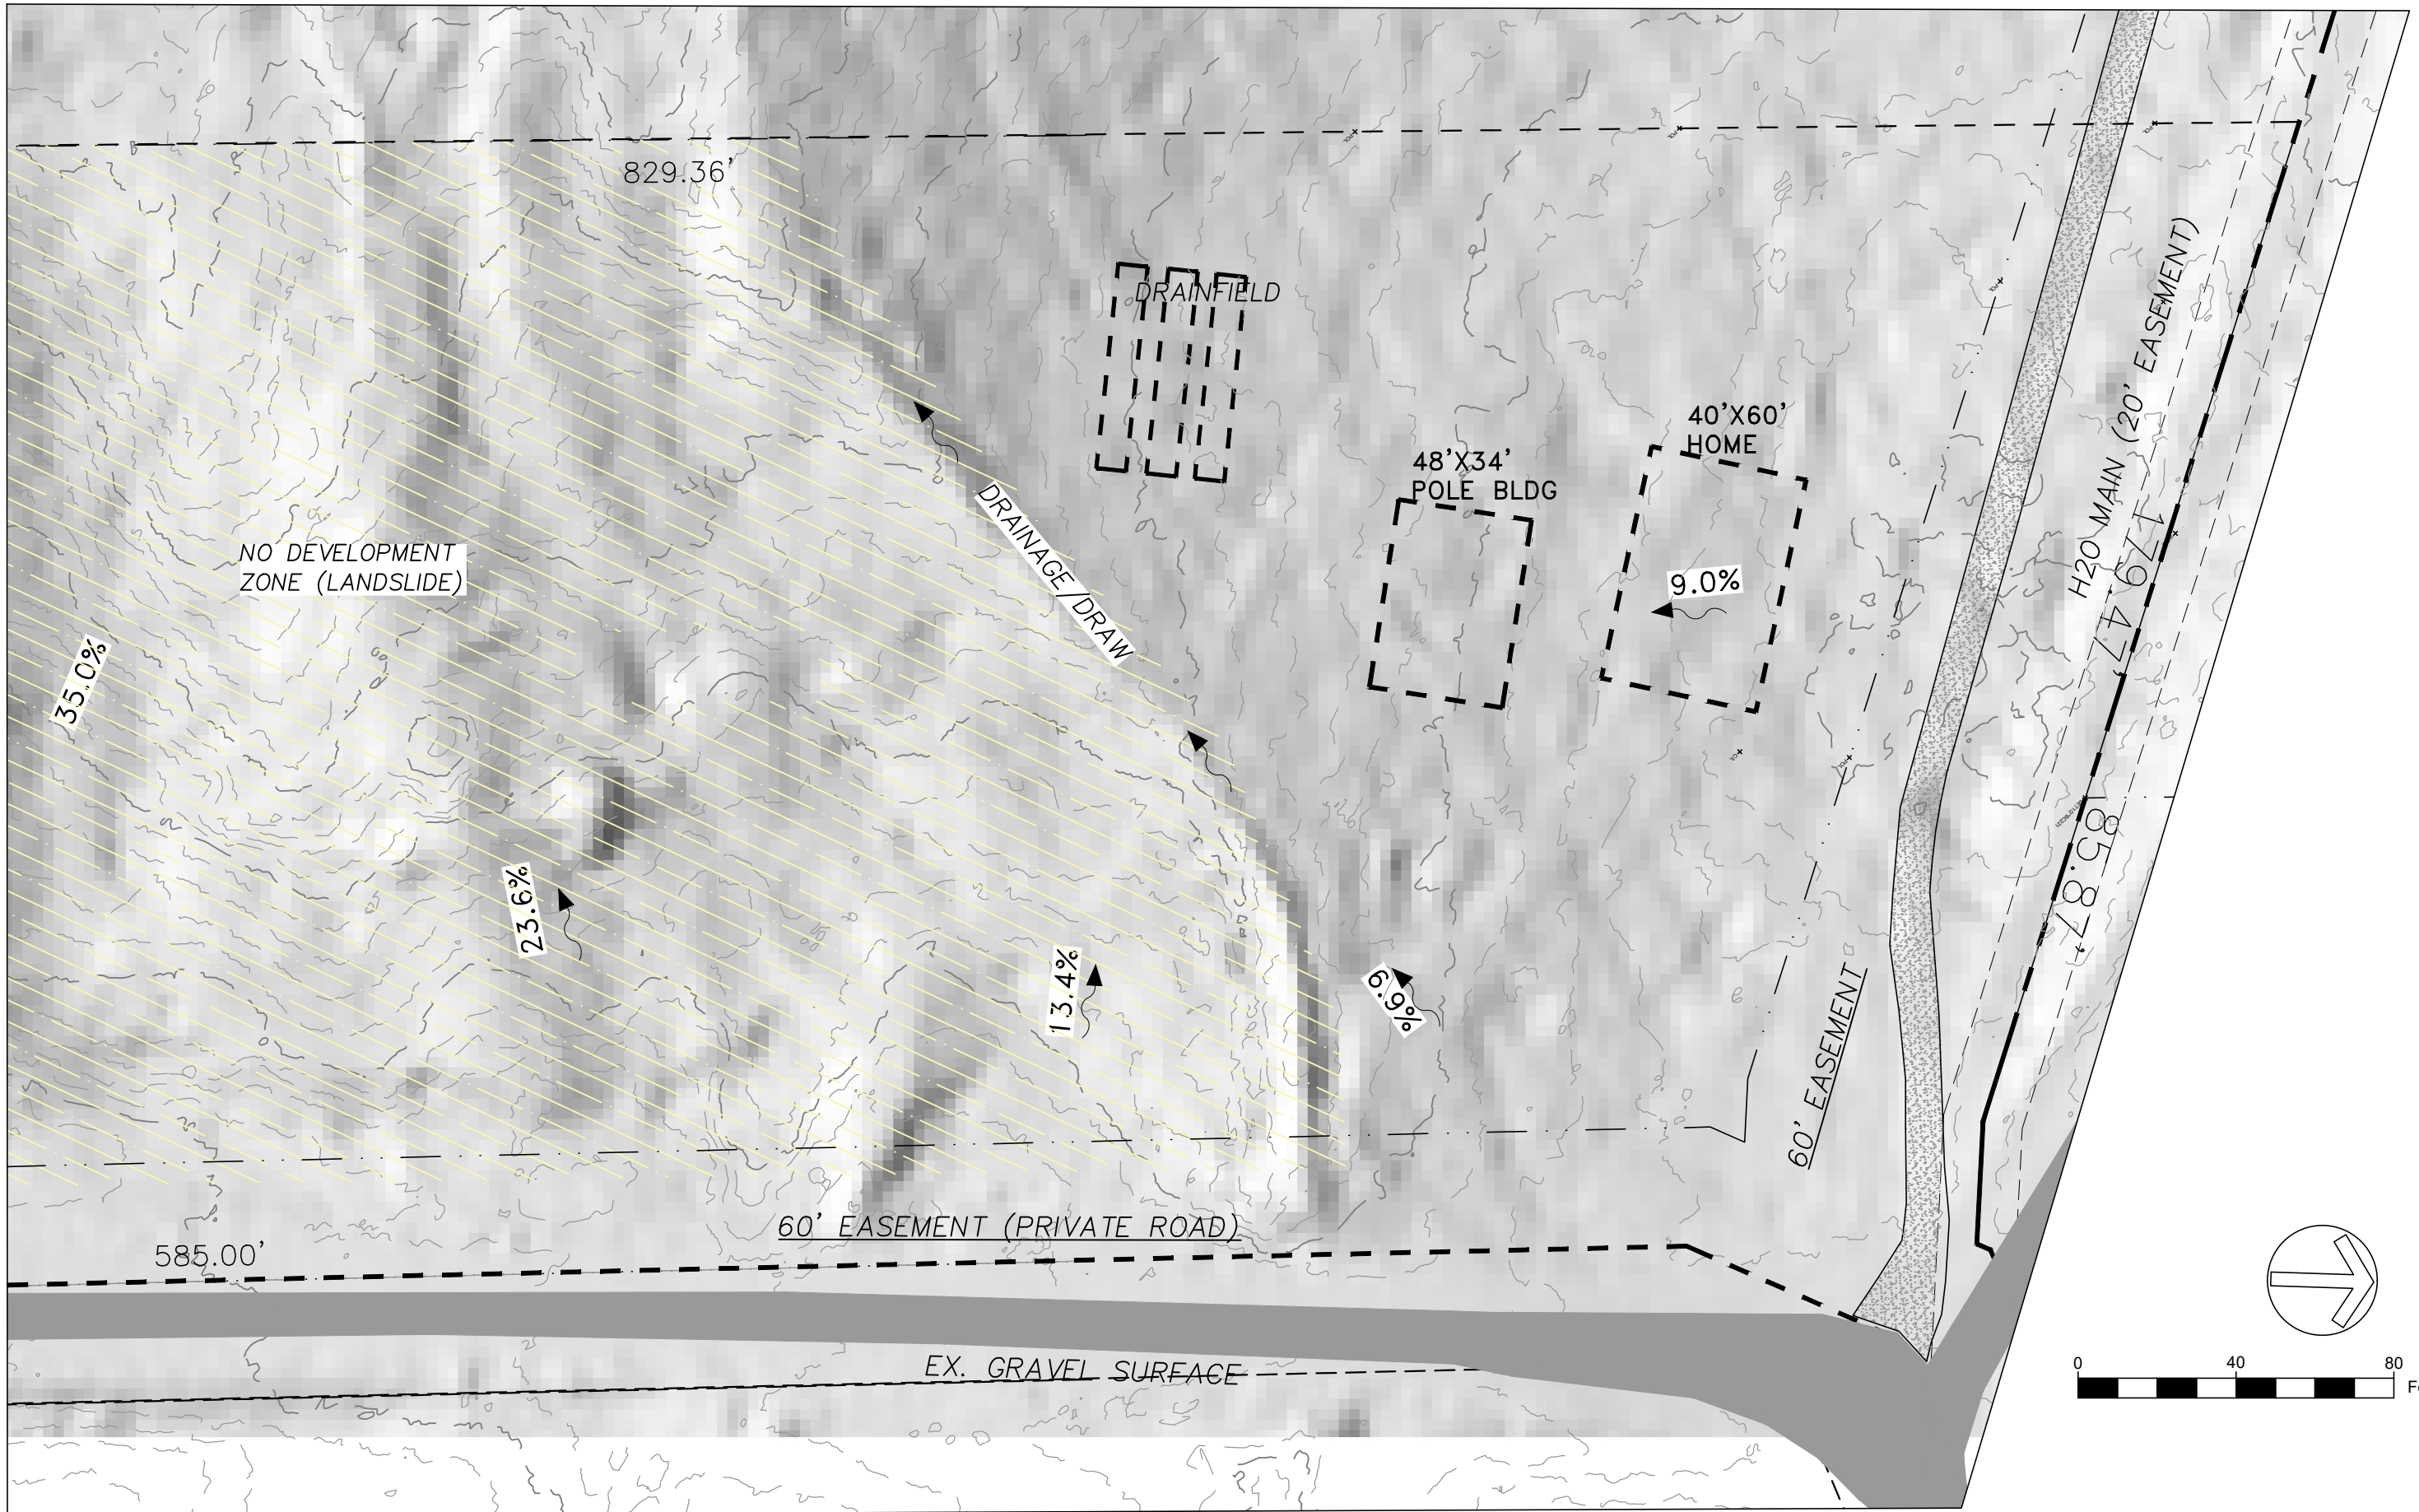
TOPOGRAPHY SOURCE: 2-FT CONTOUR INTERVALS (WA-DNR, 2016 LIDAR SURVEY)

The undersigned professional completed a reconnaissance of the study site to observe all potential geologic or landslide hazards that may be associated with the proposed site improvements. Work consisted of traversing the site and the nearby vicinity of about 200 feet or more each direction from the proposed grading areas. In addition, we evaluated the surrounding terrain utilizing our map of 2-foot elevation contours created from LiDAR point cloud data obtained by the DNR in 2016 (see Figure 2, attached).

Given that the proposed development impacts are limited to the upland, low relief portions of the property (Figure 2), we believe, the proposed development can be carried forth per these recommendations in a manner of maintaining overall slope stability and minimizing soil erosion loss. Outside of the limited area of grading and structure development shown in Figure 2, we advise the protecting the native topographic conditions of the site. To promote stormwater dispersion across the slope areas, exposed bare soil areas should be re-seeded with native grass mixes, and/or riparian (woodland) seed mixes.
