CRITICAL AREAS REPORT & BUFFER ENHANCEMENT PLAN

Willow Grove Apartments

1106 Walnut Street

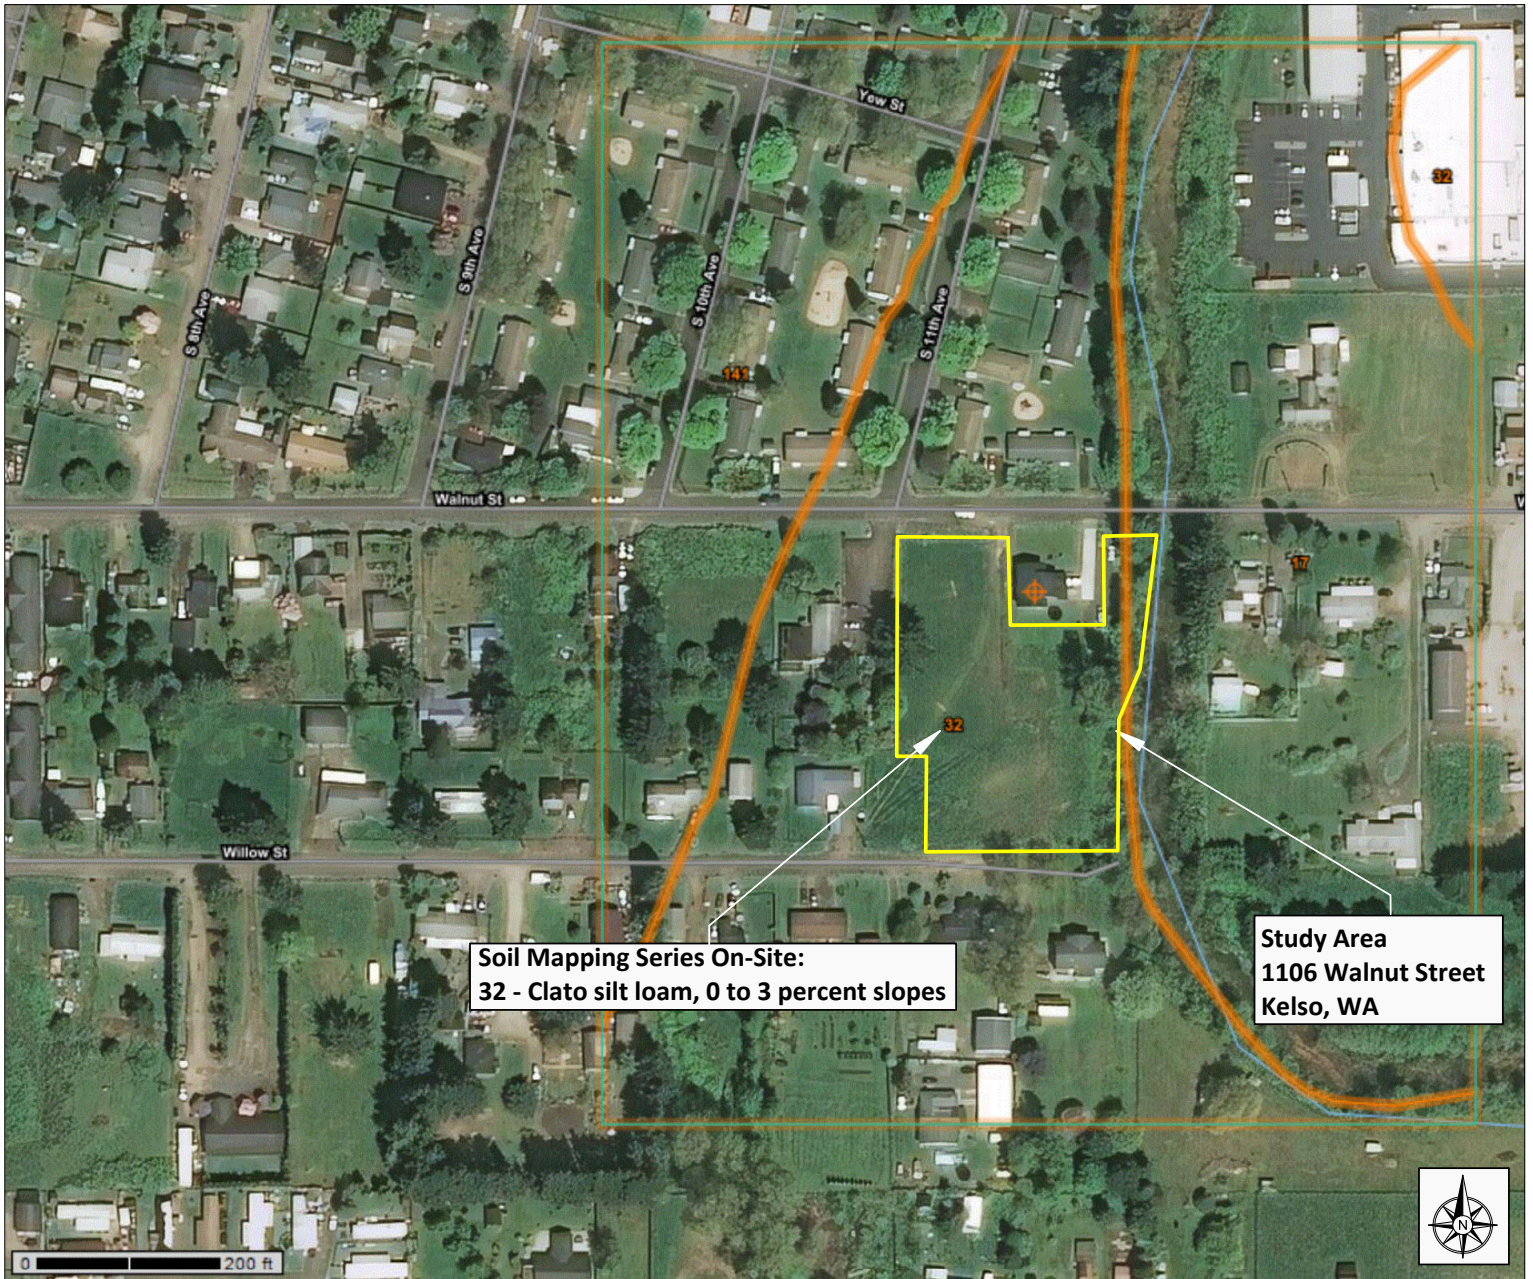
A review of the Cowlitz County GIS and USFWS National Wetland Inventory does not show the presence of wetlands or hydric soils on the project area. The property is mapped with the following non-hydric soil series (Figure 3 of 10):

- 32 - Clato silt loam, 0 to 3 percent slopes

The Clato series consists of very deep, well drained soils formed in alluvium from sedimentary and basic volcanic rocks. Clato soils are on floodplains and low terraces.

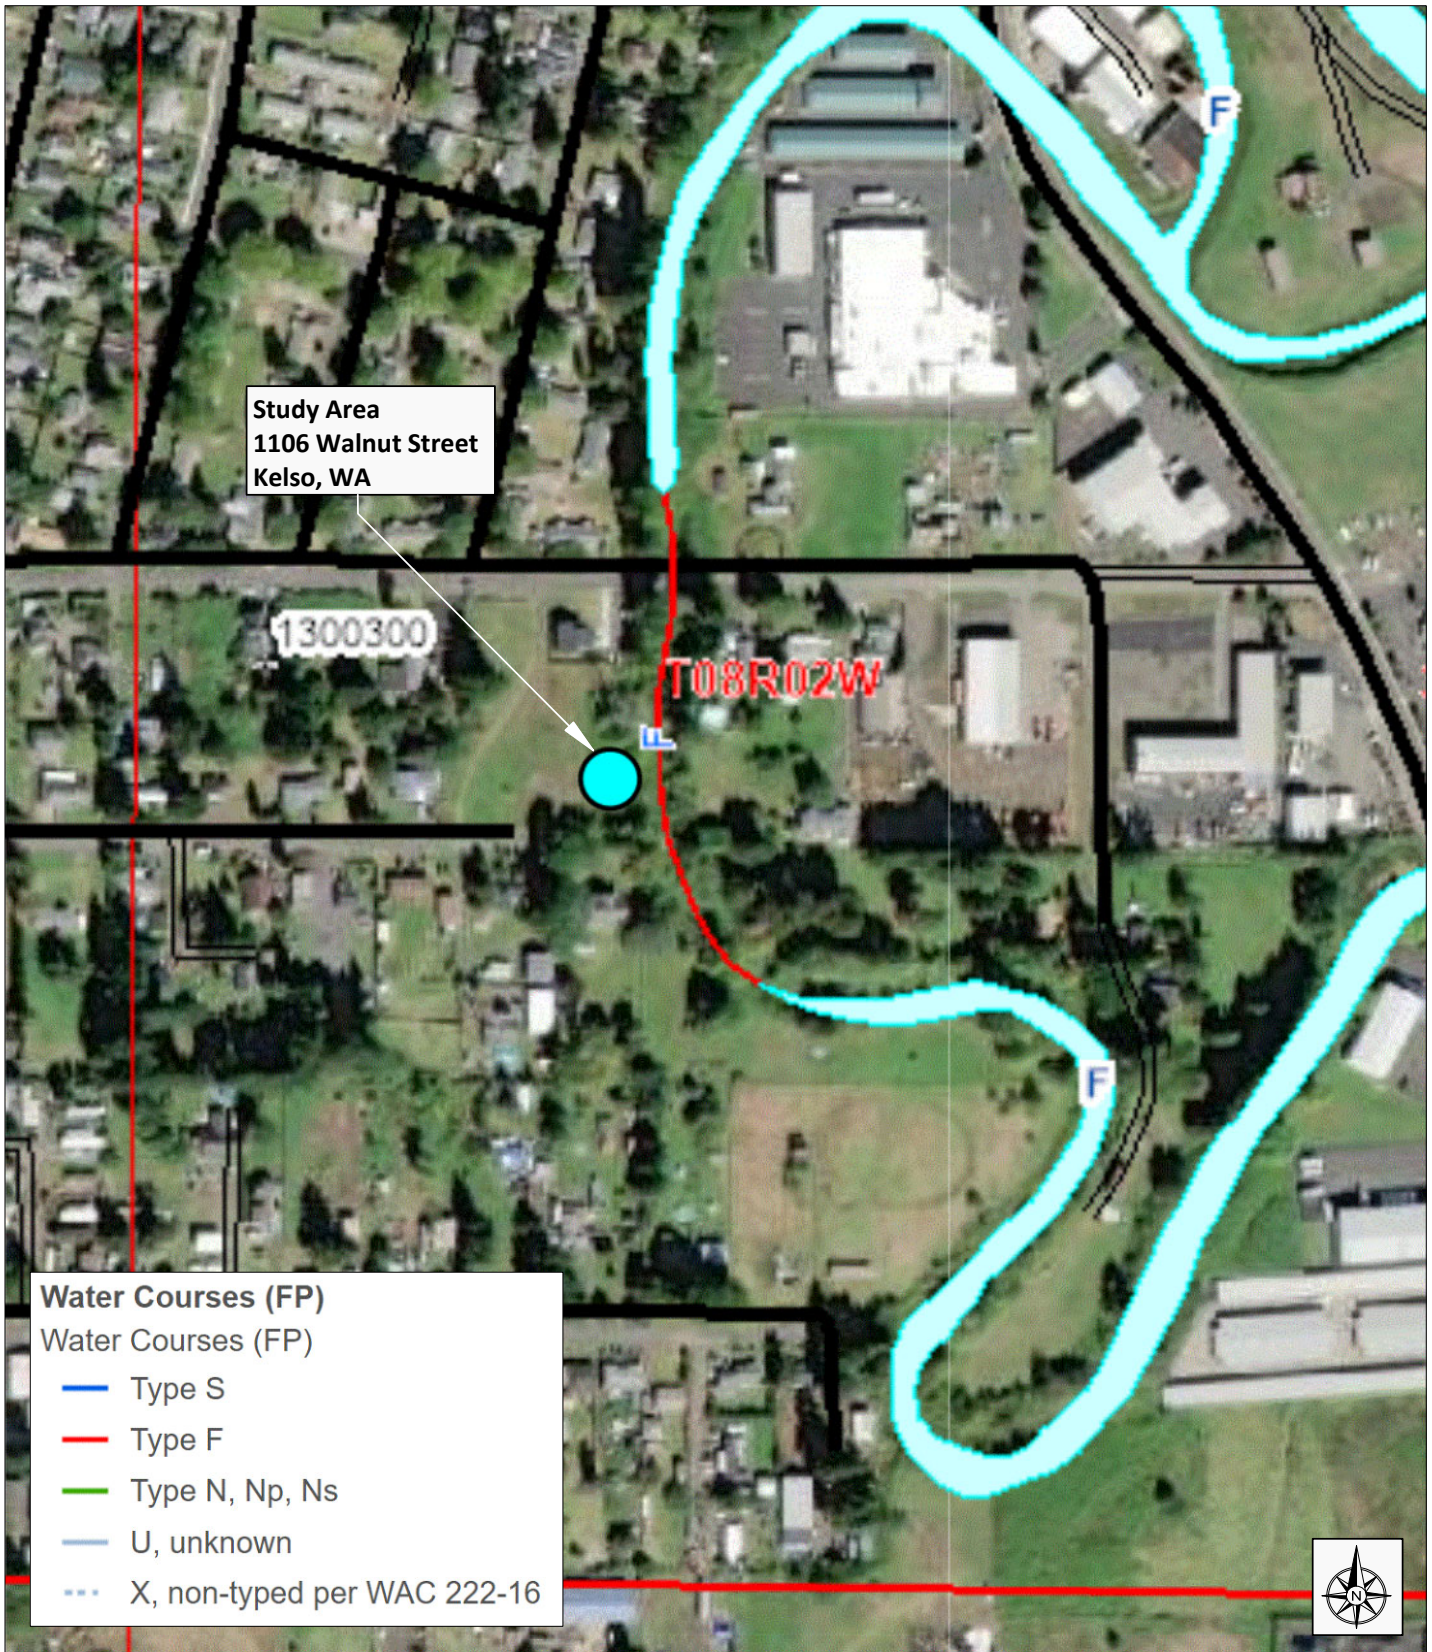
**Figure 5 of 10 - DNR FPARS Mapping
Critical Areas Report & Buffer Enhancement Plan**

The WDNR Forest Practices Application Review System (FPARS) identifies the Old Coweeman Riverbed Slough as a Type F (fish bearing water). Type F waters are defined as streams and waterbodies that are known to be used by fish, or meet the physical criteria to be potentially used by fish. Fish streams may or may not have flowing water all year; they may be perennial or seasonal. The slough contains ponded or inundated conditions all year as observed during the site visit.

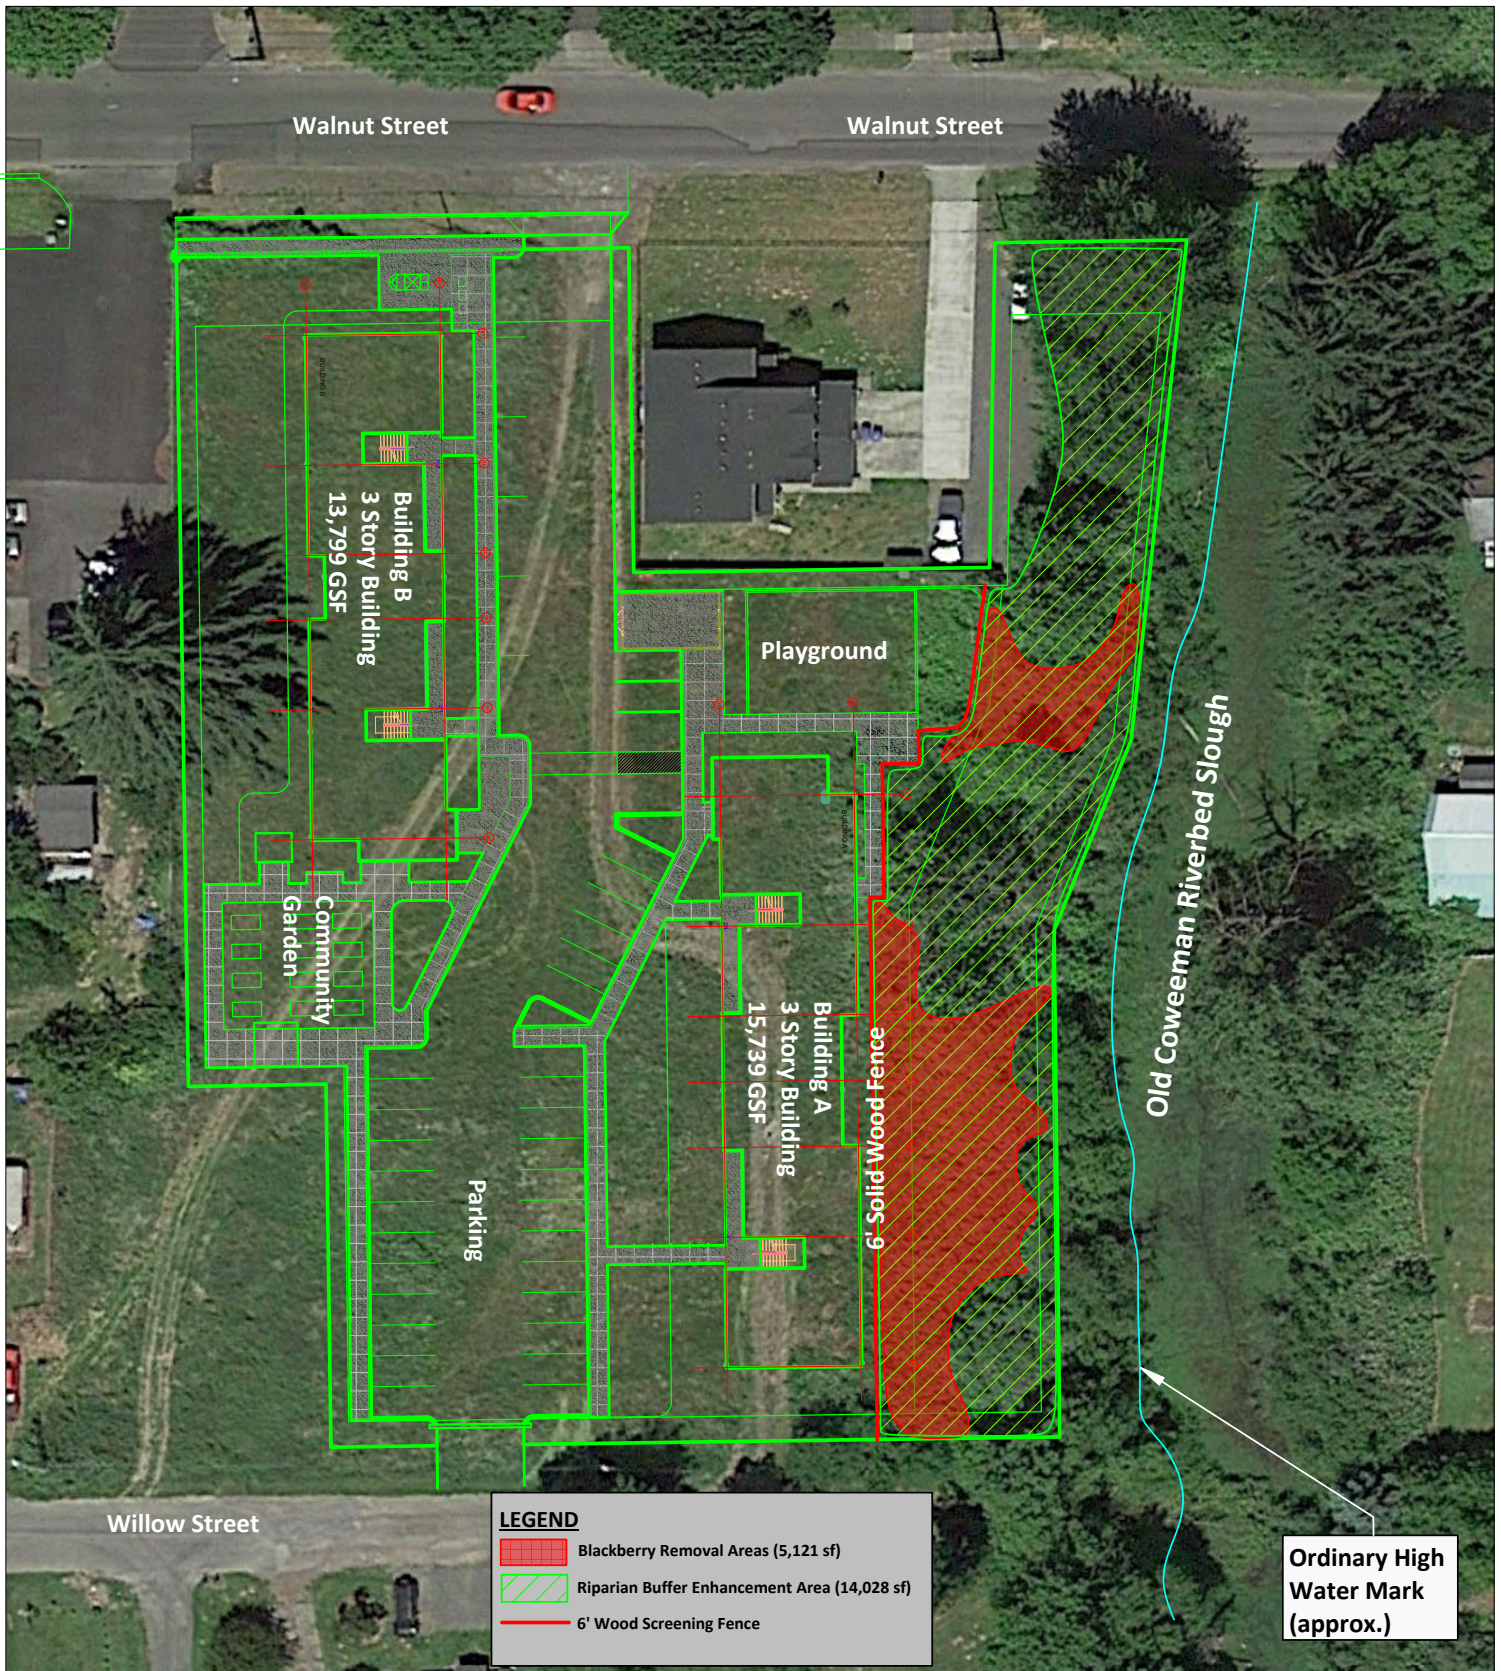
**Figure 7 of 10 - Recommended Riparian Zone and Enhancement Area
Critical Areas Report & Buffer Enhancement Plan**

It is recommended that the study area maintain a 50-to-80-foot buffer extending west from the slough as shown on Figure 7 of 10. This buffer is consistent with the existing developed properties along the majority of the slough west of Interstate 5. The wildlife functions and values will be increased by removing blackberries from the buffer and planting a variety of native shrubs and trees.

Blackberries will be removed from the riparian buffer enhancement area in the two main areas (5,121 ft²) as shown on Figure 7 of 10 but also wherever they are observed to be established. Removal of this invasive plant will allow for native plant species to re-establish providing structure, food, and nesting opportunities for a wide variety of bird species and mammals. Increased density and cover of woody vegetation over time will reduce the capacity of blackberries to dominate and outcompete the native plant species.

Riparian Buffer Enhancement Area: Plant native shrubs and trees within the 14,028 ft² buffer area as shown on Figure 7 of 10.

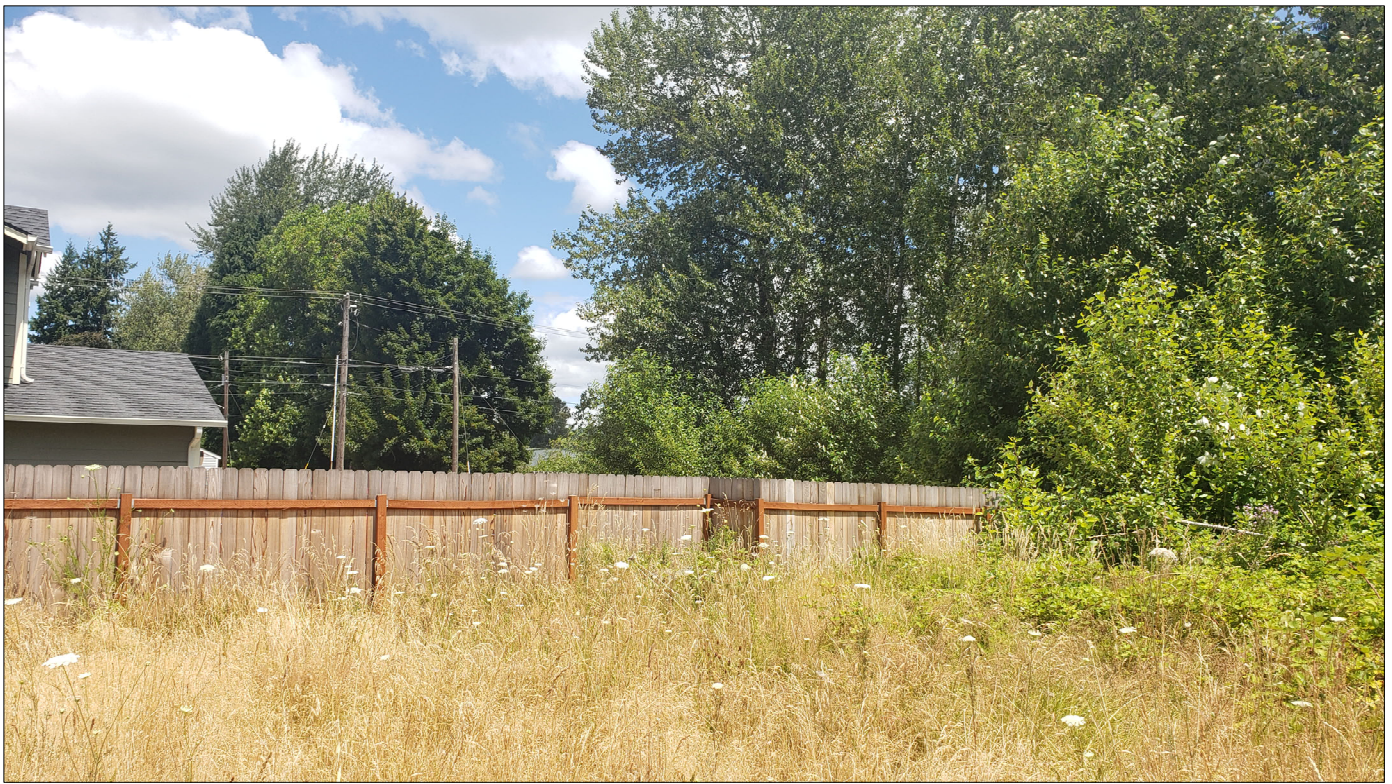
Photo 3. Northeast portion of study area in upland pasture facing east towards riparian buffer of slough.

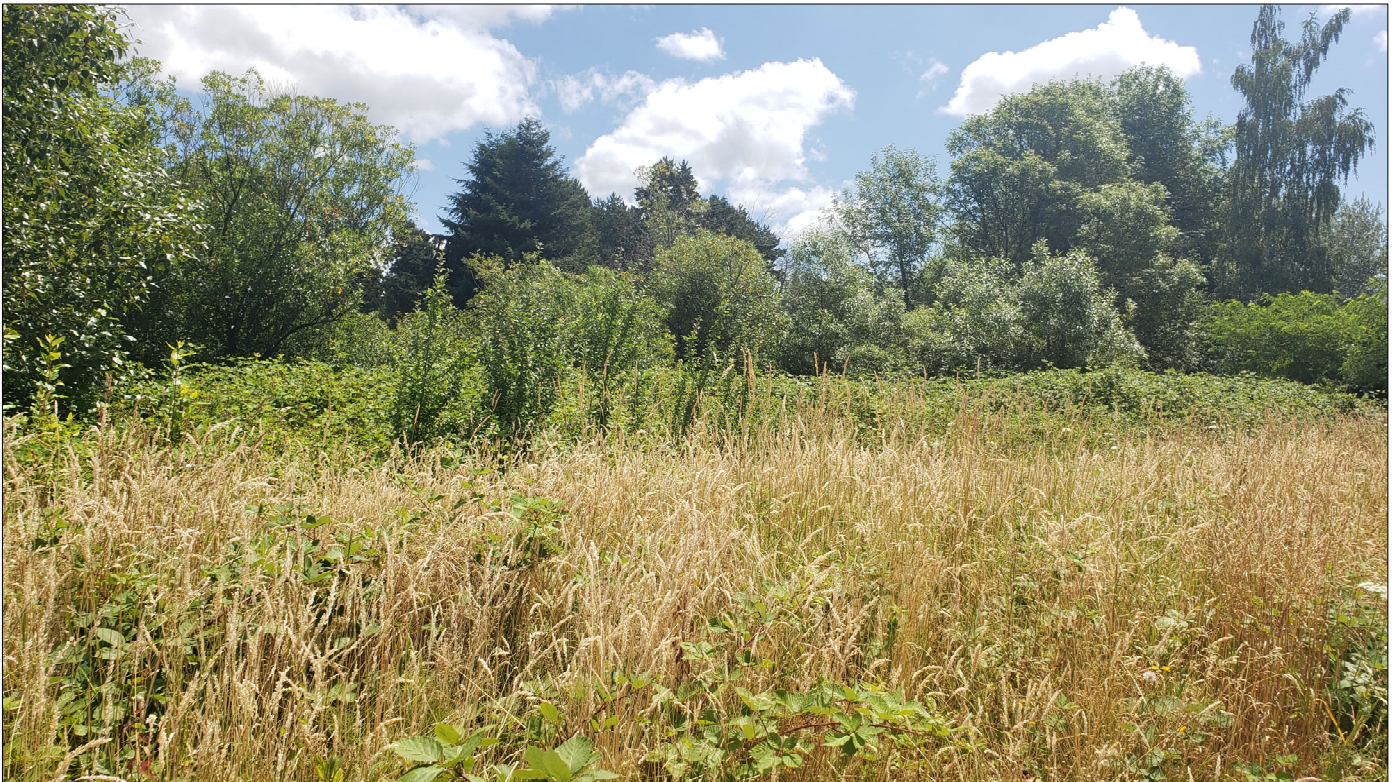
Photo 4. East portion of study area in upland pasture facing east towards riparian buffer of slough.

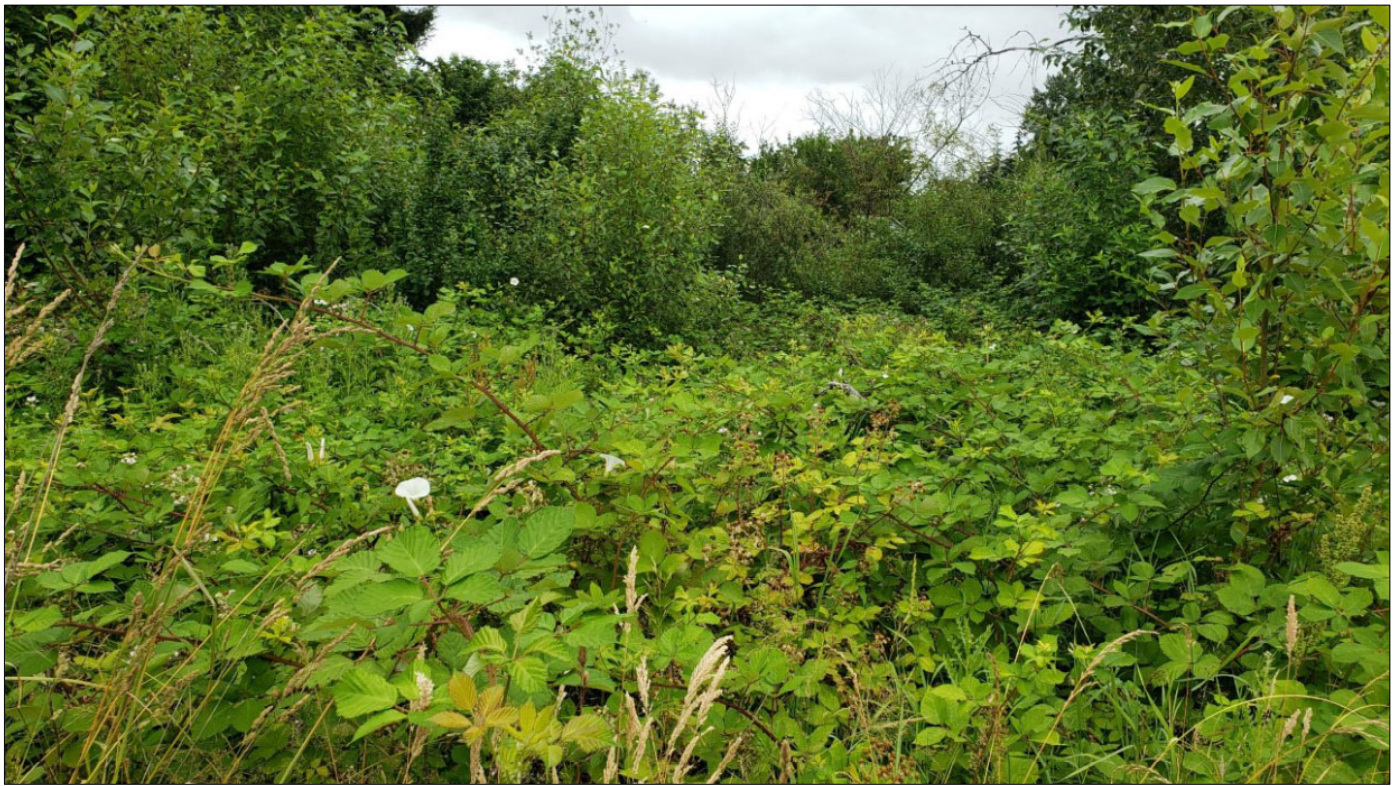
The portion of the buffer which extends into the east part of the study area contains large areas of blackberries, a non-native species, which is one of the most widespread and disruptive of all the noxious weeds in Western Washington. It displaces native species and dominates riparian habitats. It reproduces by canes and seeds, the latter of which is carried by birds and animals.

Photo 5. Typical blackberry dominated conditions along the east side of the existing riparian buffer.

Manual removal of Armenian blackberry canes is the preferred method of control on this site rather than herbicide applications to limit damage to other existing native vegetation and proximity to aquatic areas. Removal methods can include the use of machetes and mechanical brush cutters. Upon completion of the cutting of the blackberry canes in the spring prior to berry seed production, they should be arranged in scattered piles and left for cover in the forest understory for wildlife species. Blackberry canes may also be mulched with mechanically and spread on the ground surface within the mitigation area.

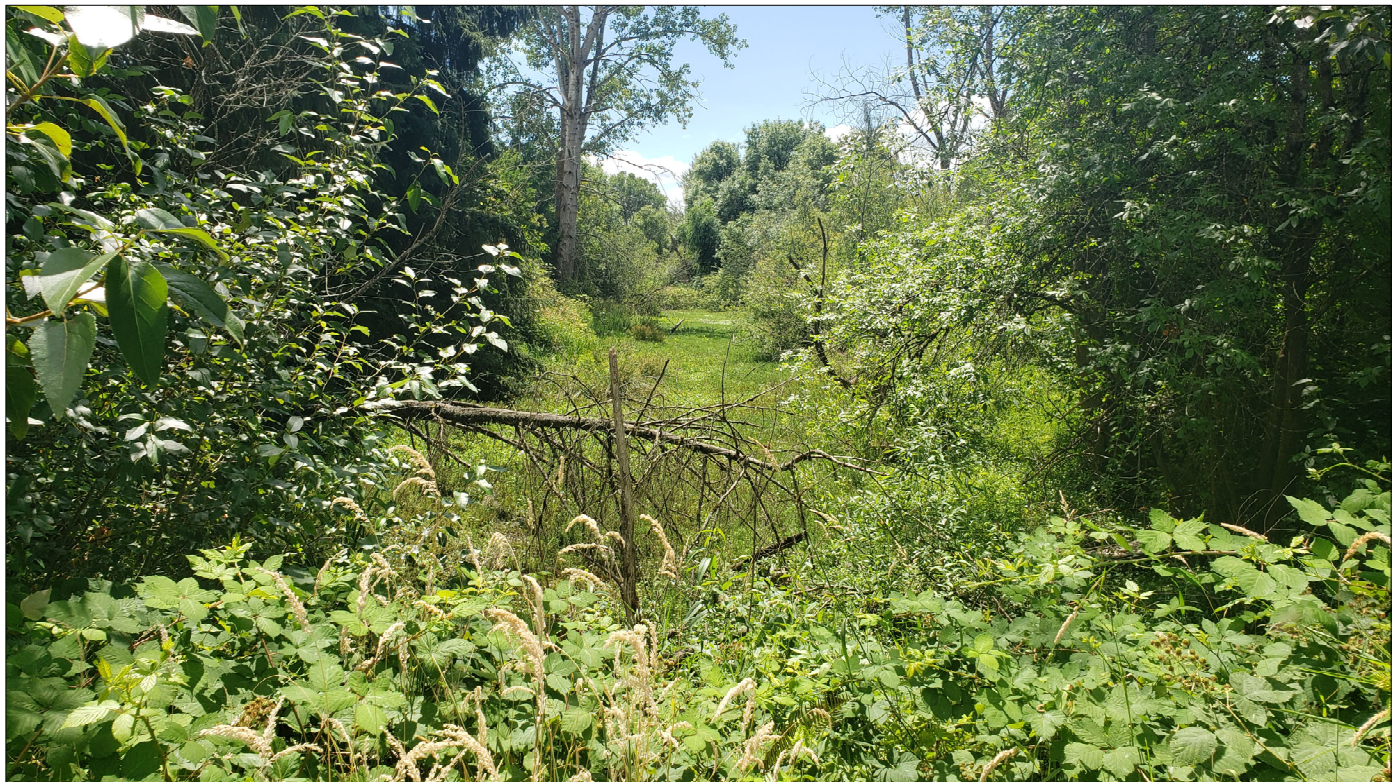
Photo 6. Photo of slough taken at Walnut St. (off-site) facing south.
