# CITY OF KELSO

## STORMWATER MANAGEMENT PLAN

*Project No. 0443.01.02*

*Maul Foster & Alongi, Inc.*  
*400 East Mill Plain Blvd., Suite 400*

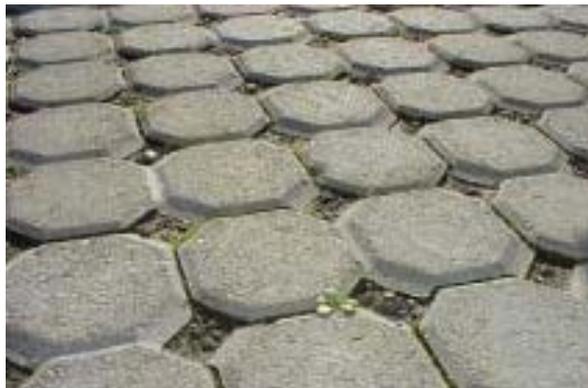
Pervious pavement is generally applicable only to light to moderate traffic areas because of its inability to accommodate heavy loads. There are many types of porous pavement, including pervious concrete and asphalt, modular block, reinforced grass, cobblestone block and gravel. When properly installed, and in the proper setting, porous pavement can be as functional and durable as traditional surfaces for these applications.

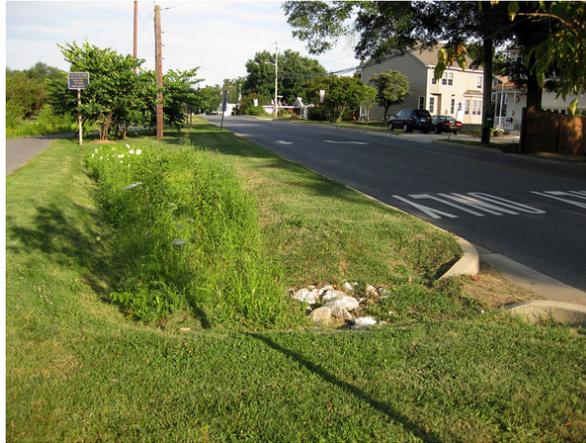
Bioretention facilities are often incorporated into street reconstruction design by excavating below street grades outside the curb line and allowing runoff to enter through curb cuts (see photo below). These facilities require suitable soil and groundwater conditions to be successful.

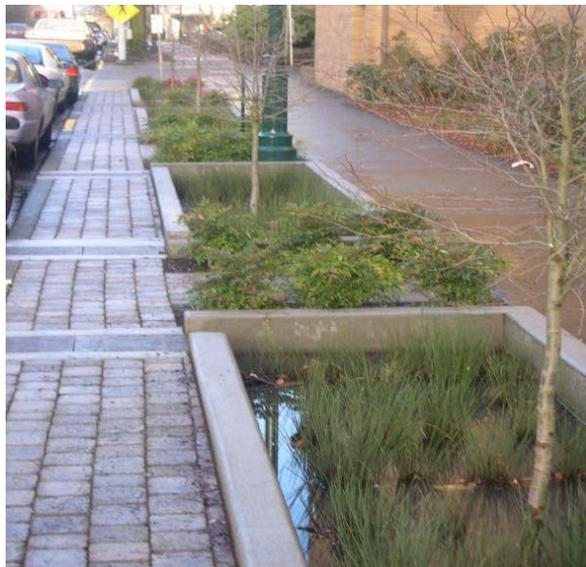
A stormwater planter is a low-lying vegetated planter that receives runoff from roof drains or adjoining paved areas. A shallow surcharge zone above the vegetated surface temporarily stores stormwater. The accumulated runoff gradually infiltrates into an underlying sand/peat bed and then into a gravel layer. If the planter is a flow through stormwater planter, it has an impermeable bottom liner and an underdrain pipe to collect the treated water and discharge it to the municipal storm drain. Planters without an impermeable bottom liner (infiltration planters) will also require an underdrain when the underlying soils are less permeable than the planter's sand/peat layer.

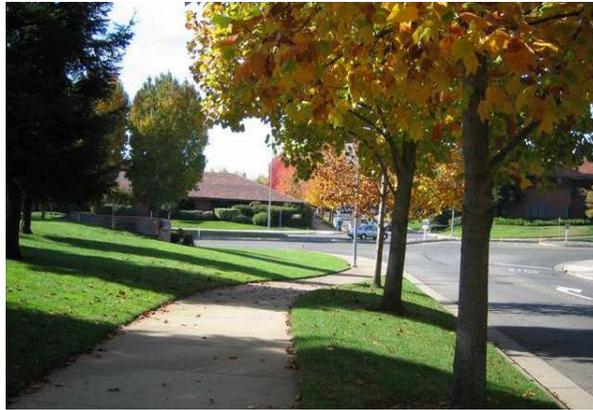
Trees intercept stormwater and can retain a significant amount of the captured water on their leaves and branches, allowing for evaporation and dissipation of the energy of runoff. Their root structures absorb and uptake runoff and associated pollutants. The shade provided by trees keeps the ground under the trees cooler, thereby reducing the amount of heat gained in runoff as it flows over the surface and into the storm drain. In turn, this helps keep stream temperatures cool and healthy for fish and other aquatic life.<sup>3</sup>

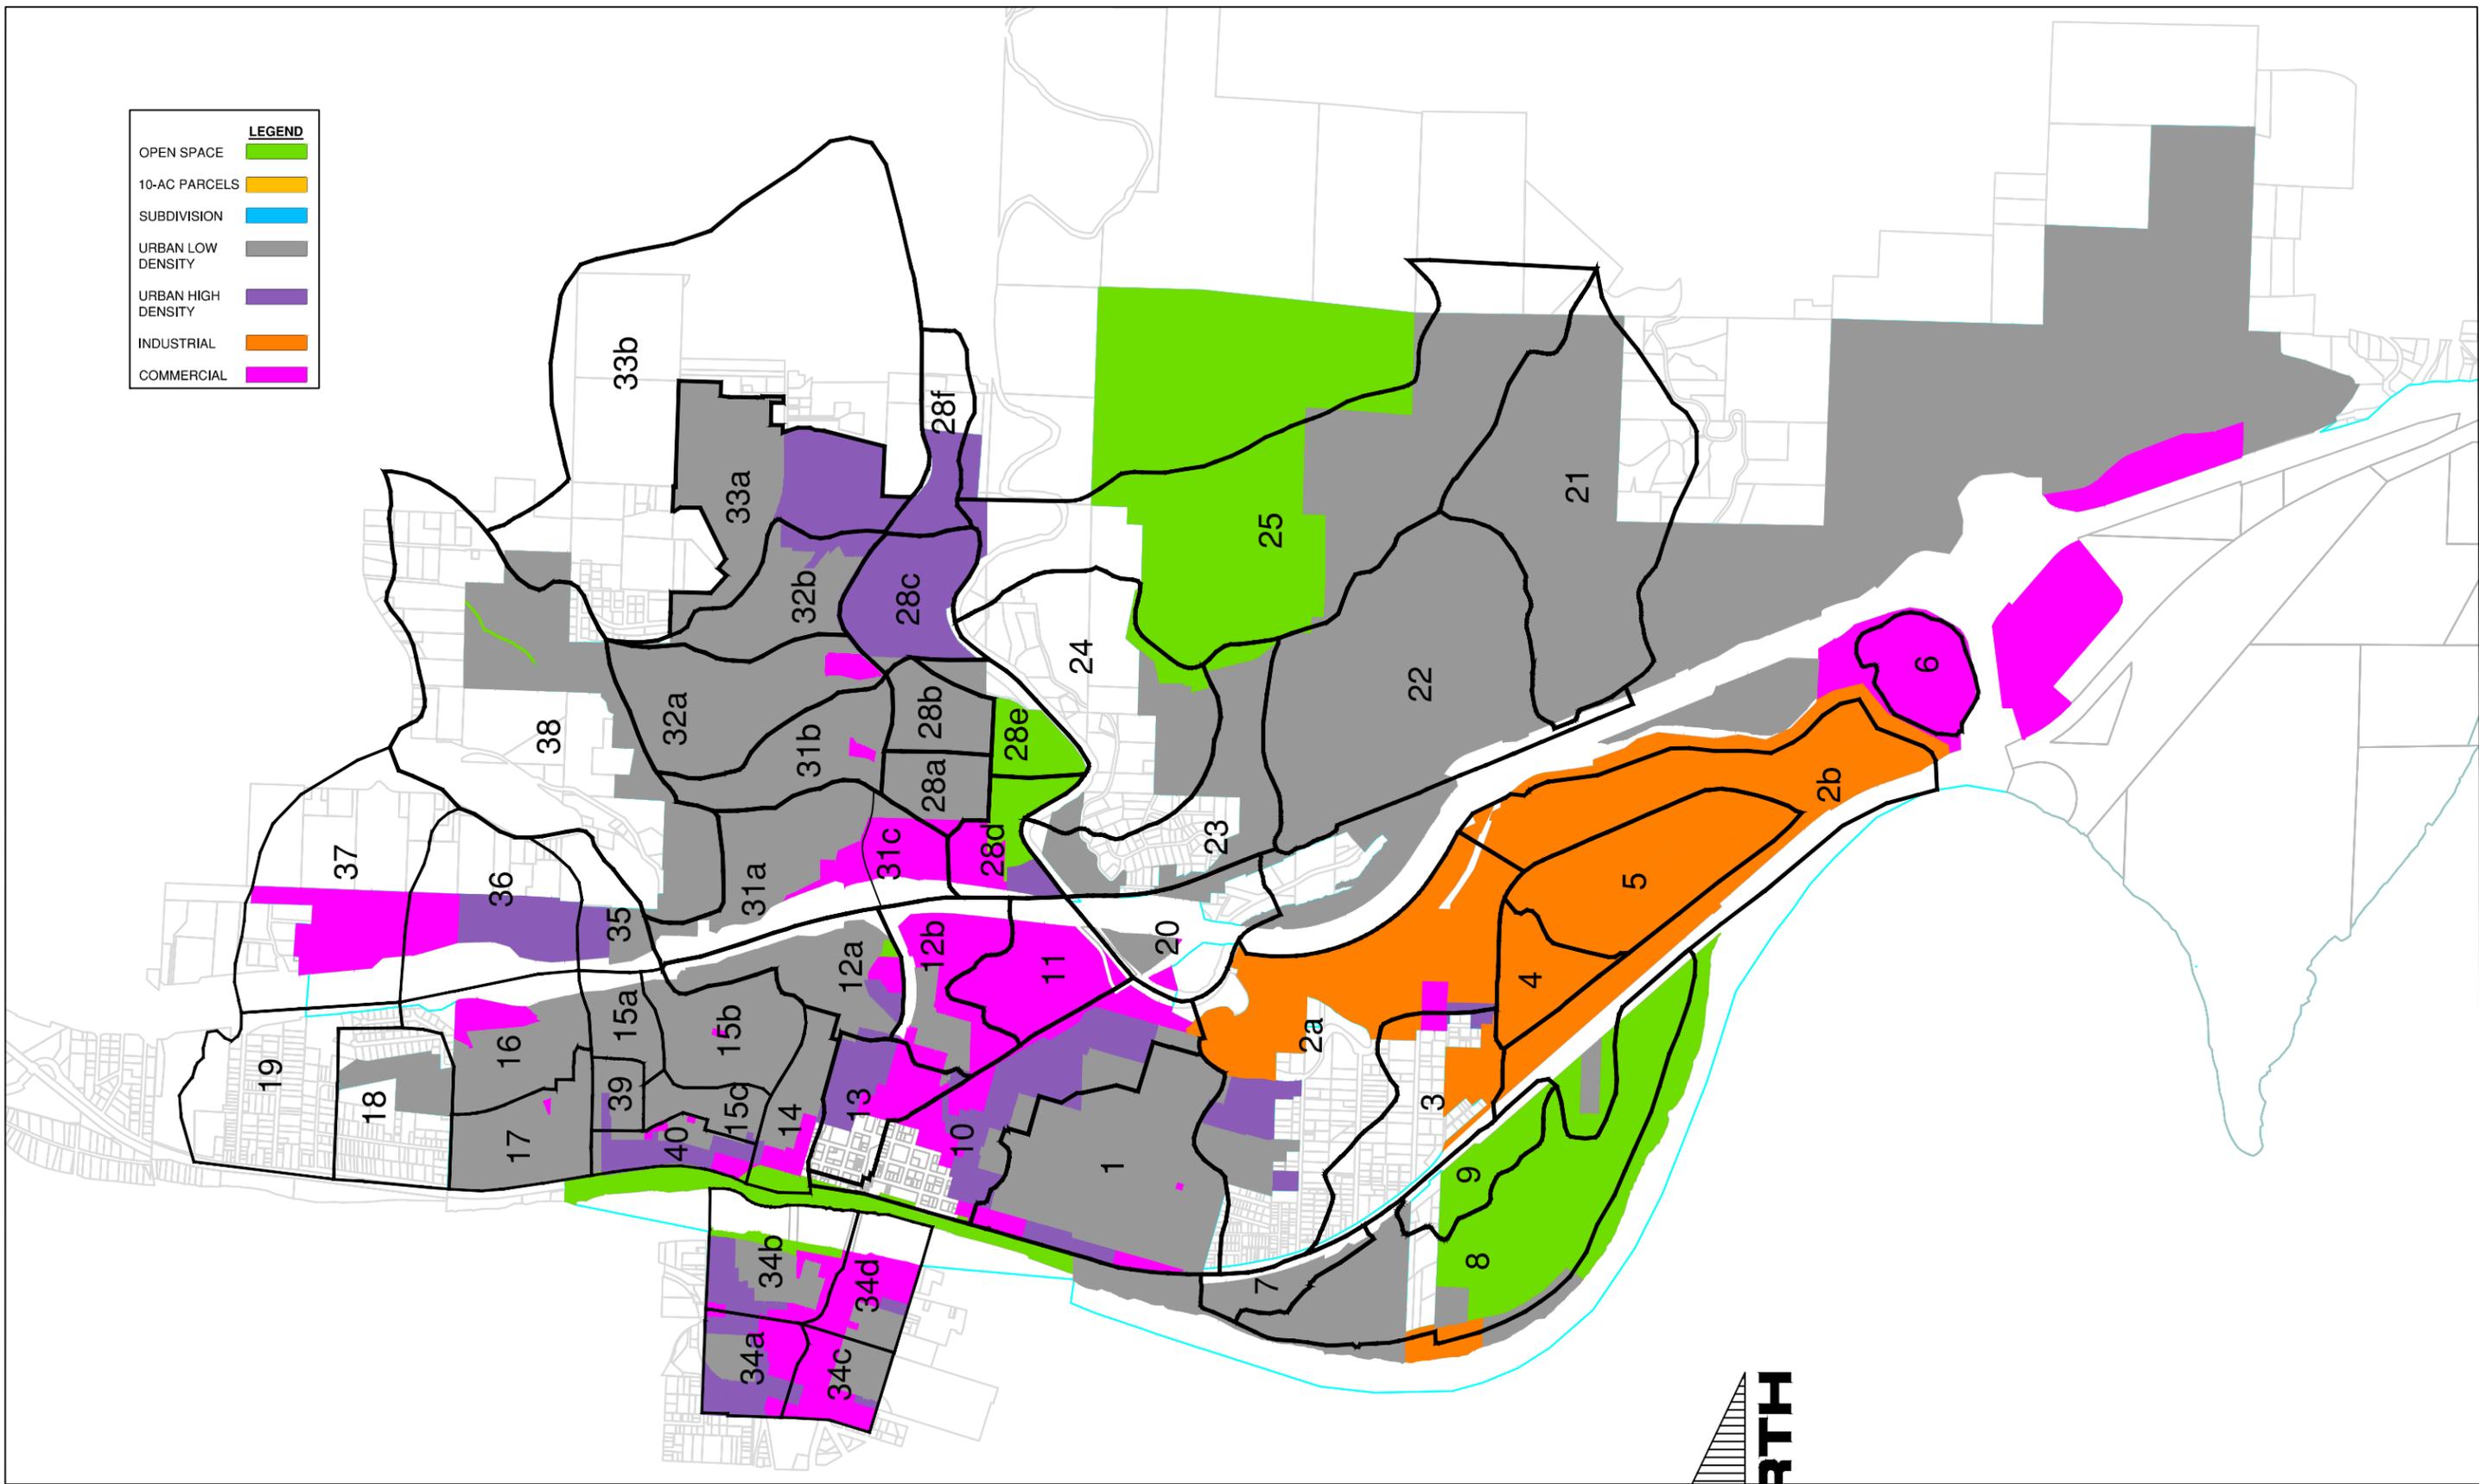
City of Kelso  
Stormwater Management Plan, Phase III  
City of Kelso Land Use Map  
Figure 3-1

LEGEND	
OPEN SPACE	
10-AC PARCELS	
SUBDIVISION	
URBAN LOW DENSITY	
URBAN HIGH DENSITY	
INDUSTRIAL	
COMMERCIAL

The Kelso watershed areas were modeled evaluating the existing land use. In most cases, the existing land use conditions were applied according to the level of development that exists today as shown in Figure 3-1: City of Kelso Land Use Map. All changes to existing land use designations are shown in Table 3-1 and Figure 3-2: Changes to Land Use Designation for Modeling Purposes.

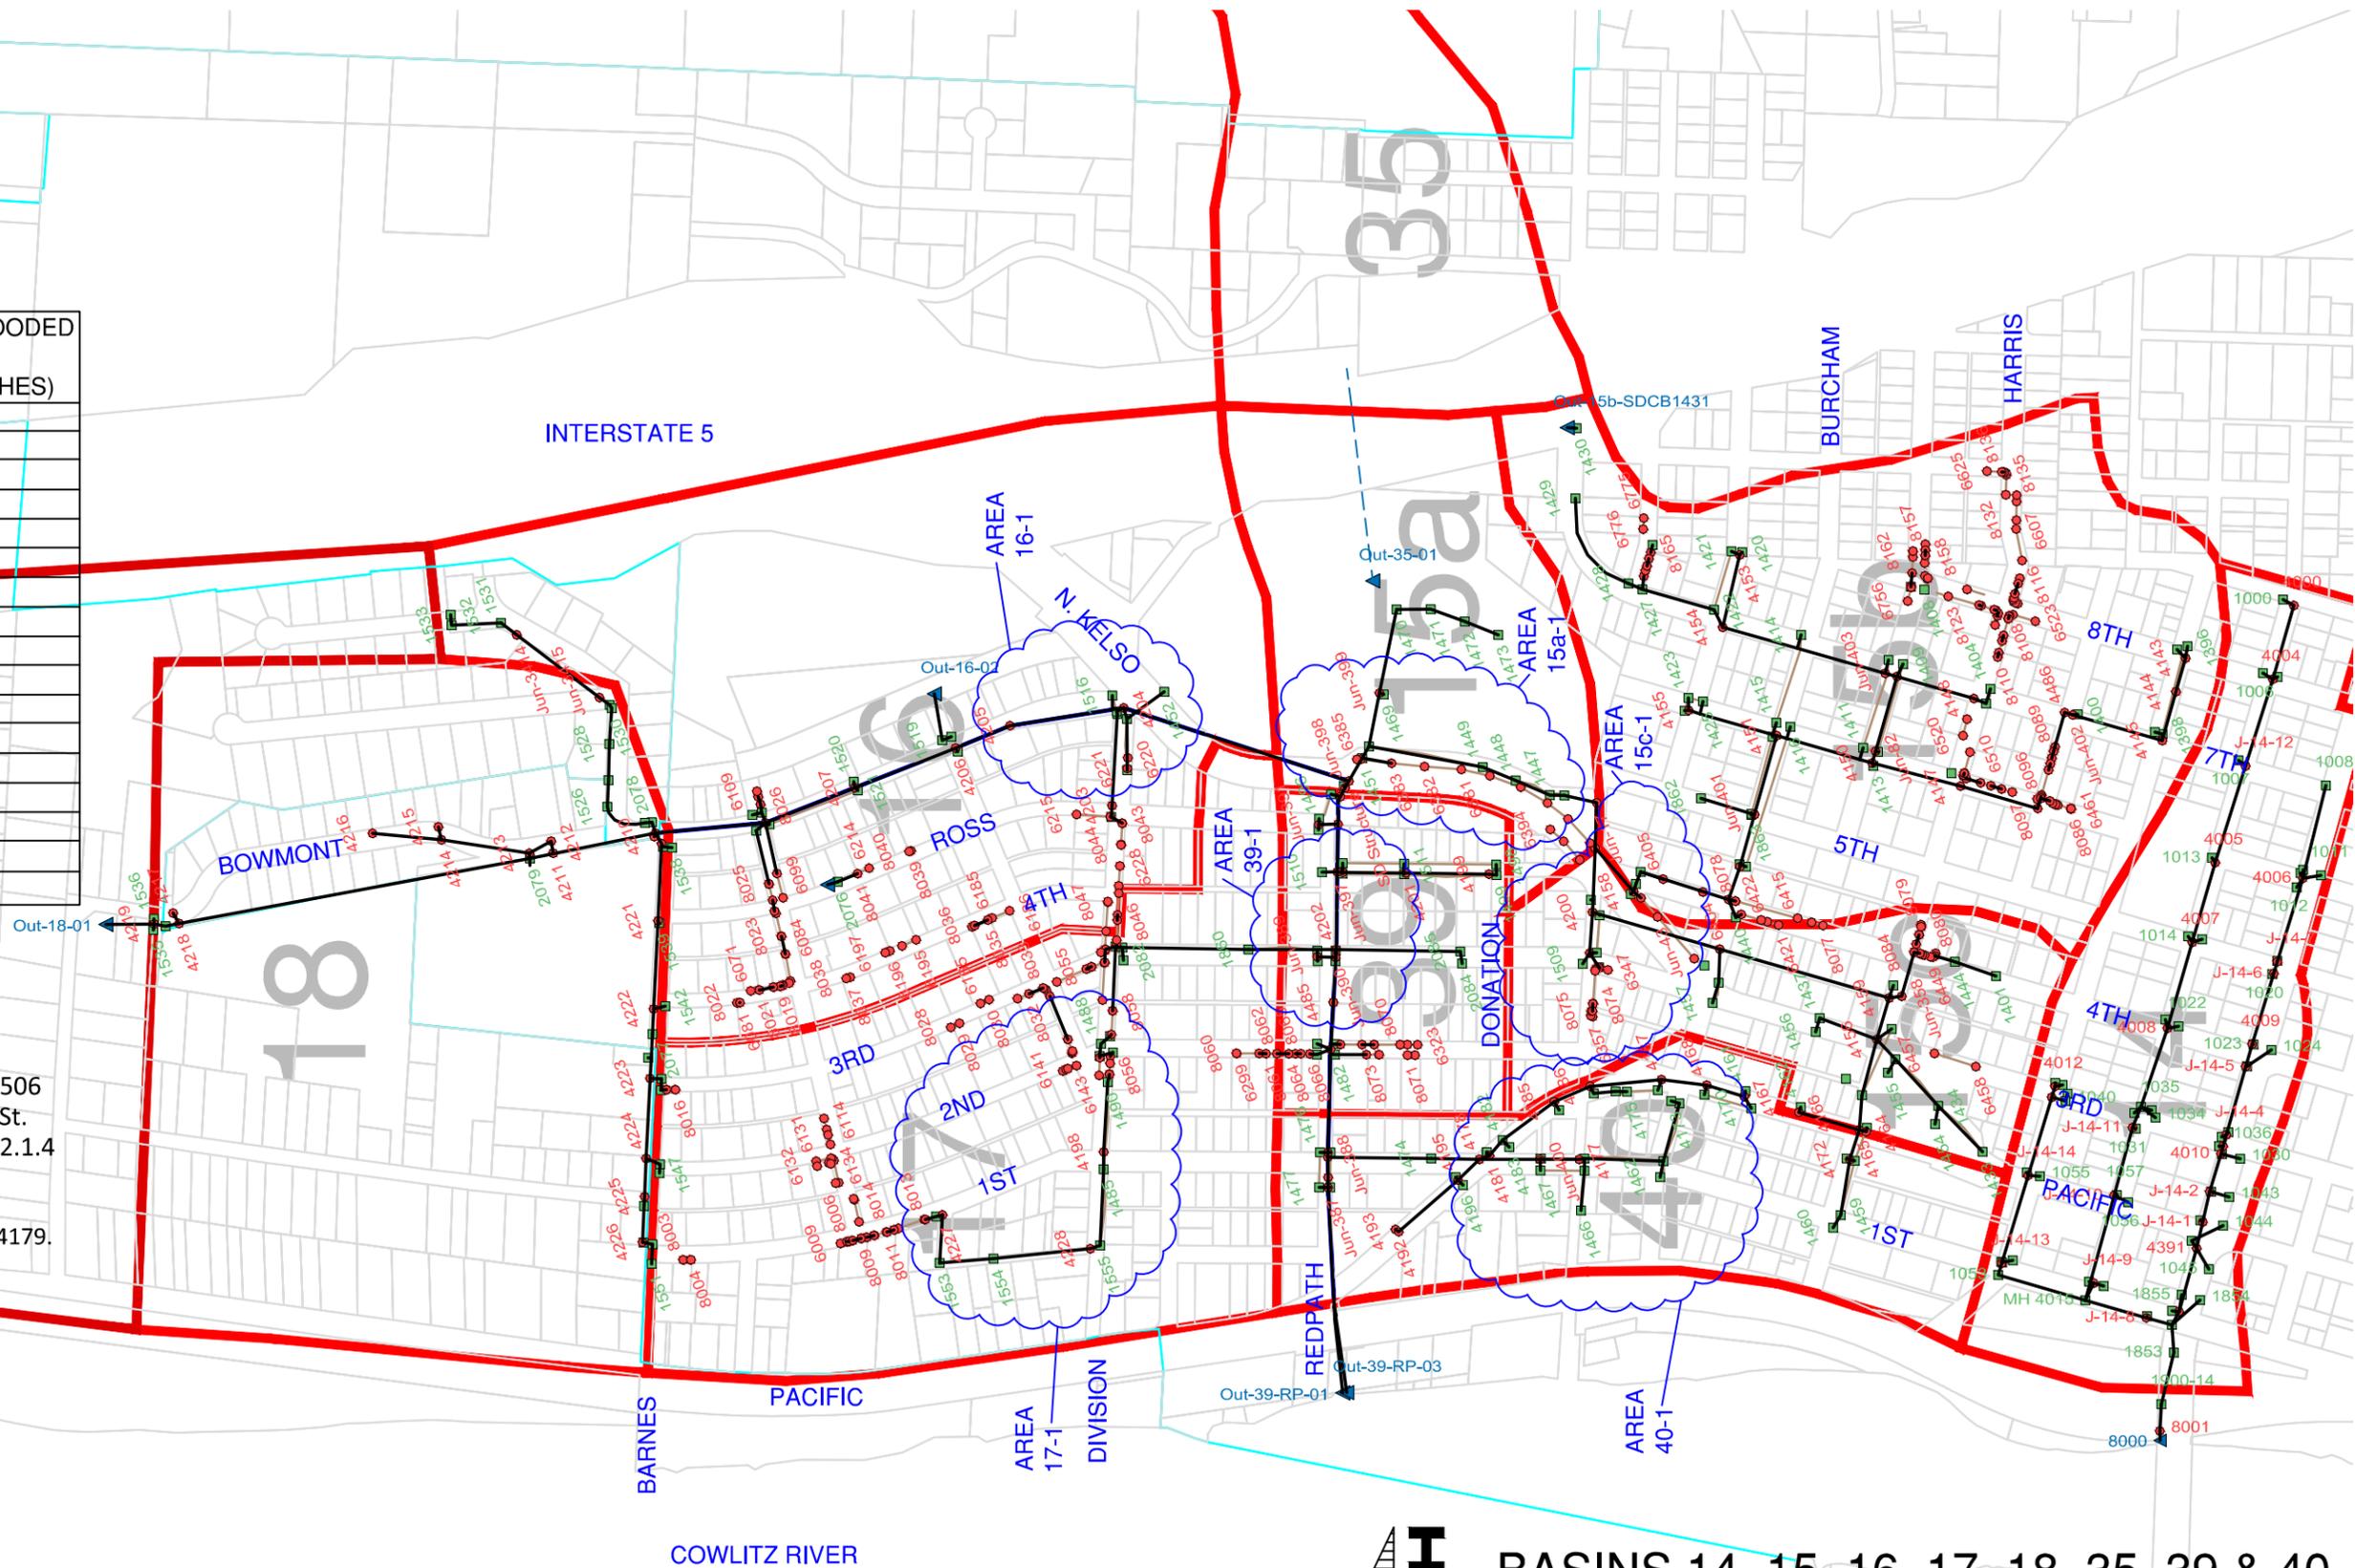
City of Kelso  
 Stormwater Management Plan, Phase III  
 Redpath-North Kelso Watershed  
 Areas of Concern, 25-Year Storm  
 Figure A-2b

\*\* Pipes linking catch basins 1503-1506 with the box culvert under Redpath St. are all at adverse grade. See Ch. 5.2.2.1.4 (Sub-basin 39, Area 1).

\*\*\* Surcharging is likely due to lack of information on water quality structure 4179. See Ch. 5.2.2.1.6 (Basin 40, Area 1).

BASINS 14, 15, 16, 17, 18, 35, 39 & 40

This basin contains two structures (1451 and 1448) in the 15a-1 area that cause the highest volume of flooding (three times higher than all the other locations in the basin) near the intersection of North Kelso Avenue and Redpath Street adjacent to Huntington Middle School. The area discharges to a 4-foot-by-4-foot box culvert that flows to DID No.1's Redpath PS. The PS has more flow capacity than the box culvert can deliver to the PS, so it is likely that the flooding is caused by lack of capacity in the box culvert. The flooding may be exacerbated by a possible accumulation of sediment in the box culvert, but this condition has not been confirmed as the box culvert has limited access for inspection. The hydraulic model showed that a properly sized box culvert would start with 4 feet by 4 feet at the upper end (see Figures V-2a and A-10a) and transition to 4 feet by 16.5 feet at the lower end. The box culvert is part of DID No.1 system but, regardless of ownership, it would be very expensive to solve the basin 15-a drainage issues by using this type of drainage structure. A second option may be to acquire property and create a detention pond that could hold runoff from a storm and release it more slowly. It would be necessary to conduct further investigation of the hydraulic requirements of this option.

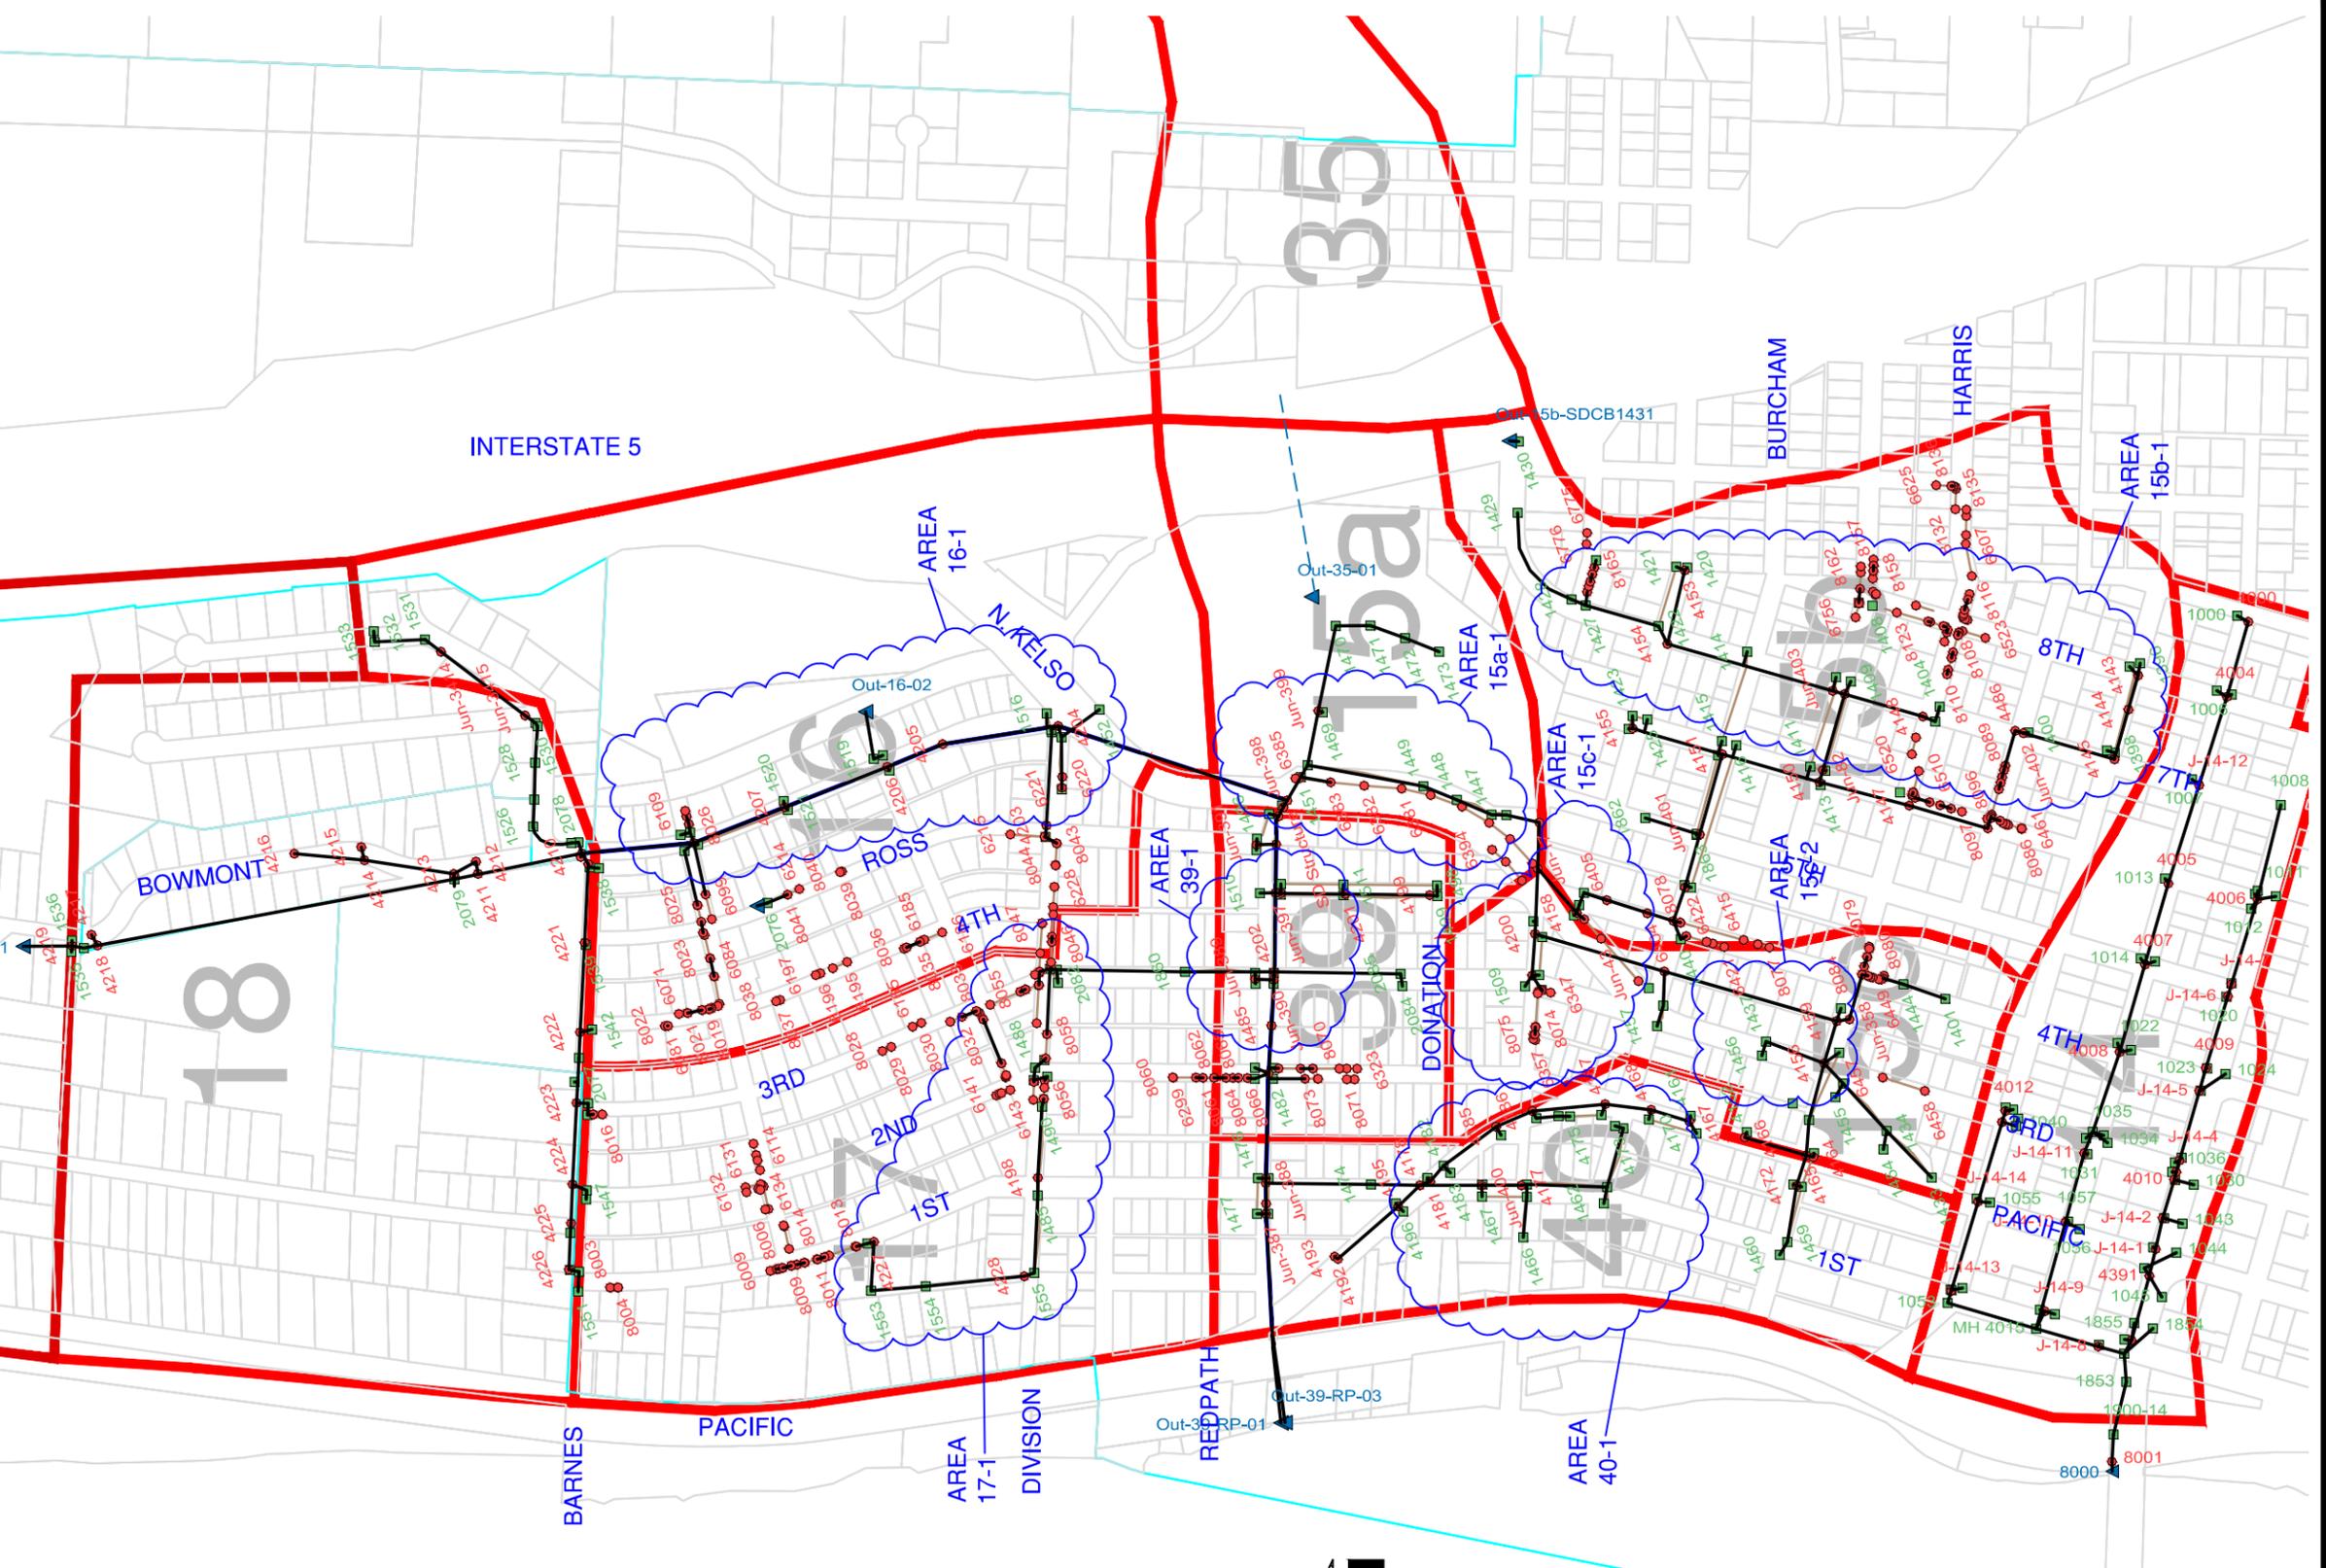
City of Kelso  
 Stormwater Management Plan, Phase III  
 Redpath-North Kelso Watershed  
 Areas of Concern, 100-Year Storm  
 Figure A-2c

STRUCTURE NUMBER	DEPTH (FT.)	TOTAL FLOODED VOLUME (ACRE-INCHES)
1451	0.29	314.24
1448	0.48	142.36
1441	0.19	83.07
1442	0.38	5.55
1483*	0.08	1.07
1500*	0.24	1.13
1501*	0.31	5.70
1509*	0.24	0.26
1486	0.34	27.79
1487	0.45	20.64
1490	0.57	11.96
2081	0.55	14.93
1554	0.45	31.68
1503**	0.20	2.99
1504**	0.20	2.89
1505**	0.20	0.38
1506	0.40	13.36
1456	0.24	13.58
1461***	0.22	1.18
1463***	0.16	0.50
1467***	0.32	4.16
2086***	0.21	0.71
1514	0.45	28.90
1515	0.55	18.74
1524	0.45	11.98
1399	0.33	12.14
1422	0.22	14.64

\* These catch basins have small diameter pipes (6-inch) and discontinuous ditches which require further action. See Ch. 5.2.2.1.2 (Sub-basin 15c, Area 1).  
 \*\* Pipes linking catch basins 1503-1506 with the box culvert under Redpath St. are all at adverse grade. See Ch. 5.2.2.1.4 (Sub-basin 39, Area 1).  
 \*\*\* Surcharging is likely due to lack of information on water quality structure 4179. See Ch. 5.2.2.1.6 (Basin 40, Area 1).

**BASINS 14, 15, 16, 17, 18, 35, 39 & 40**

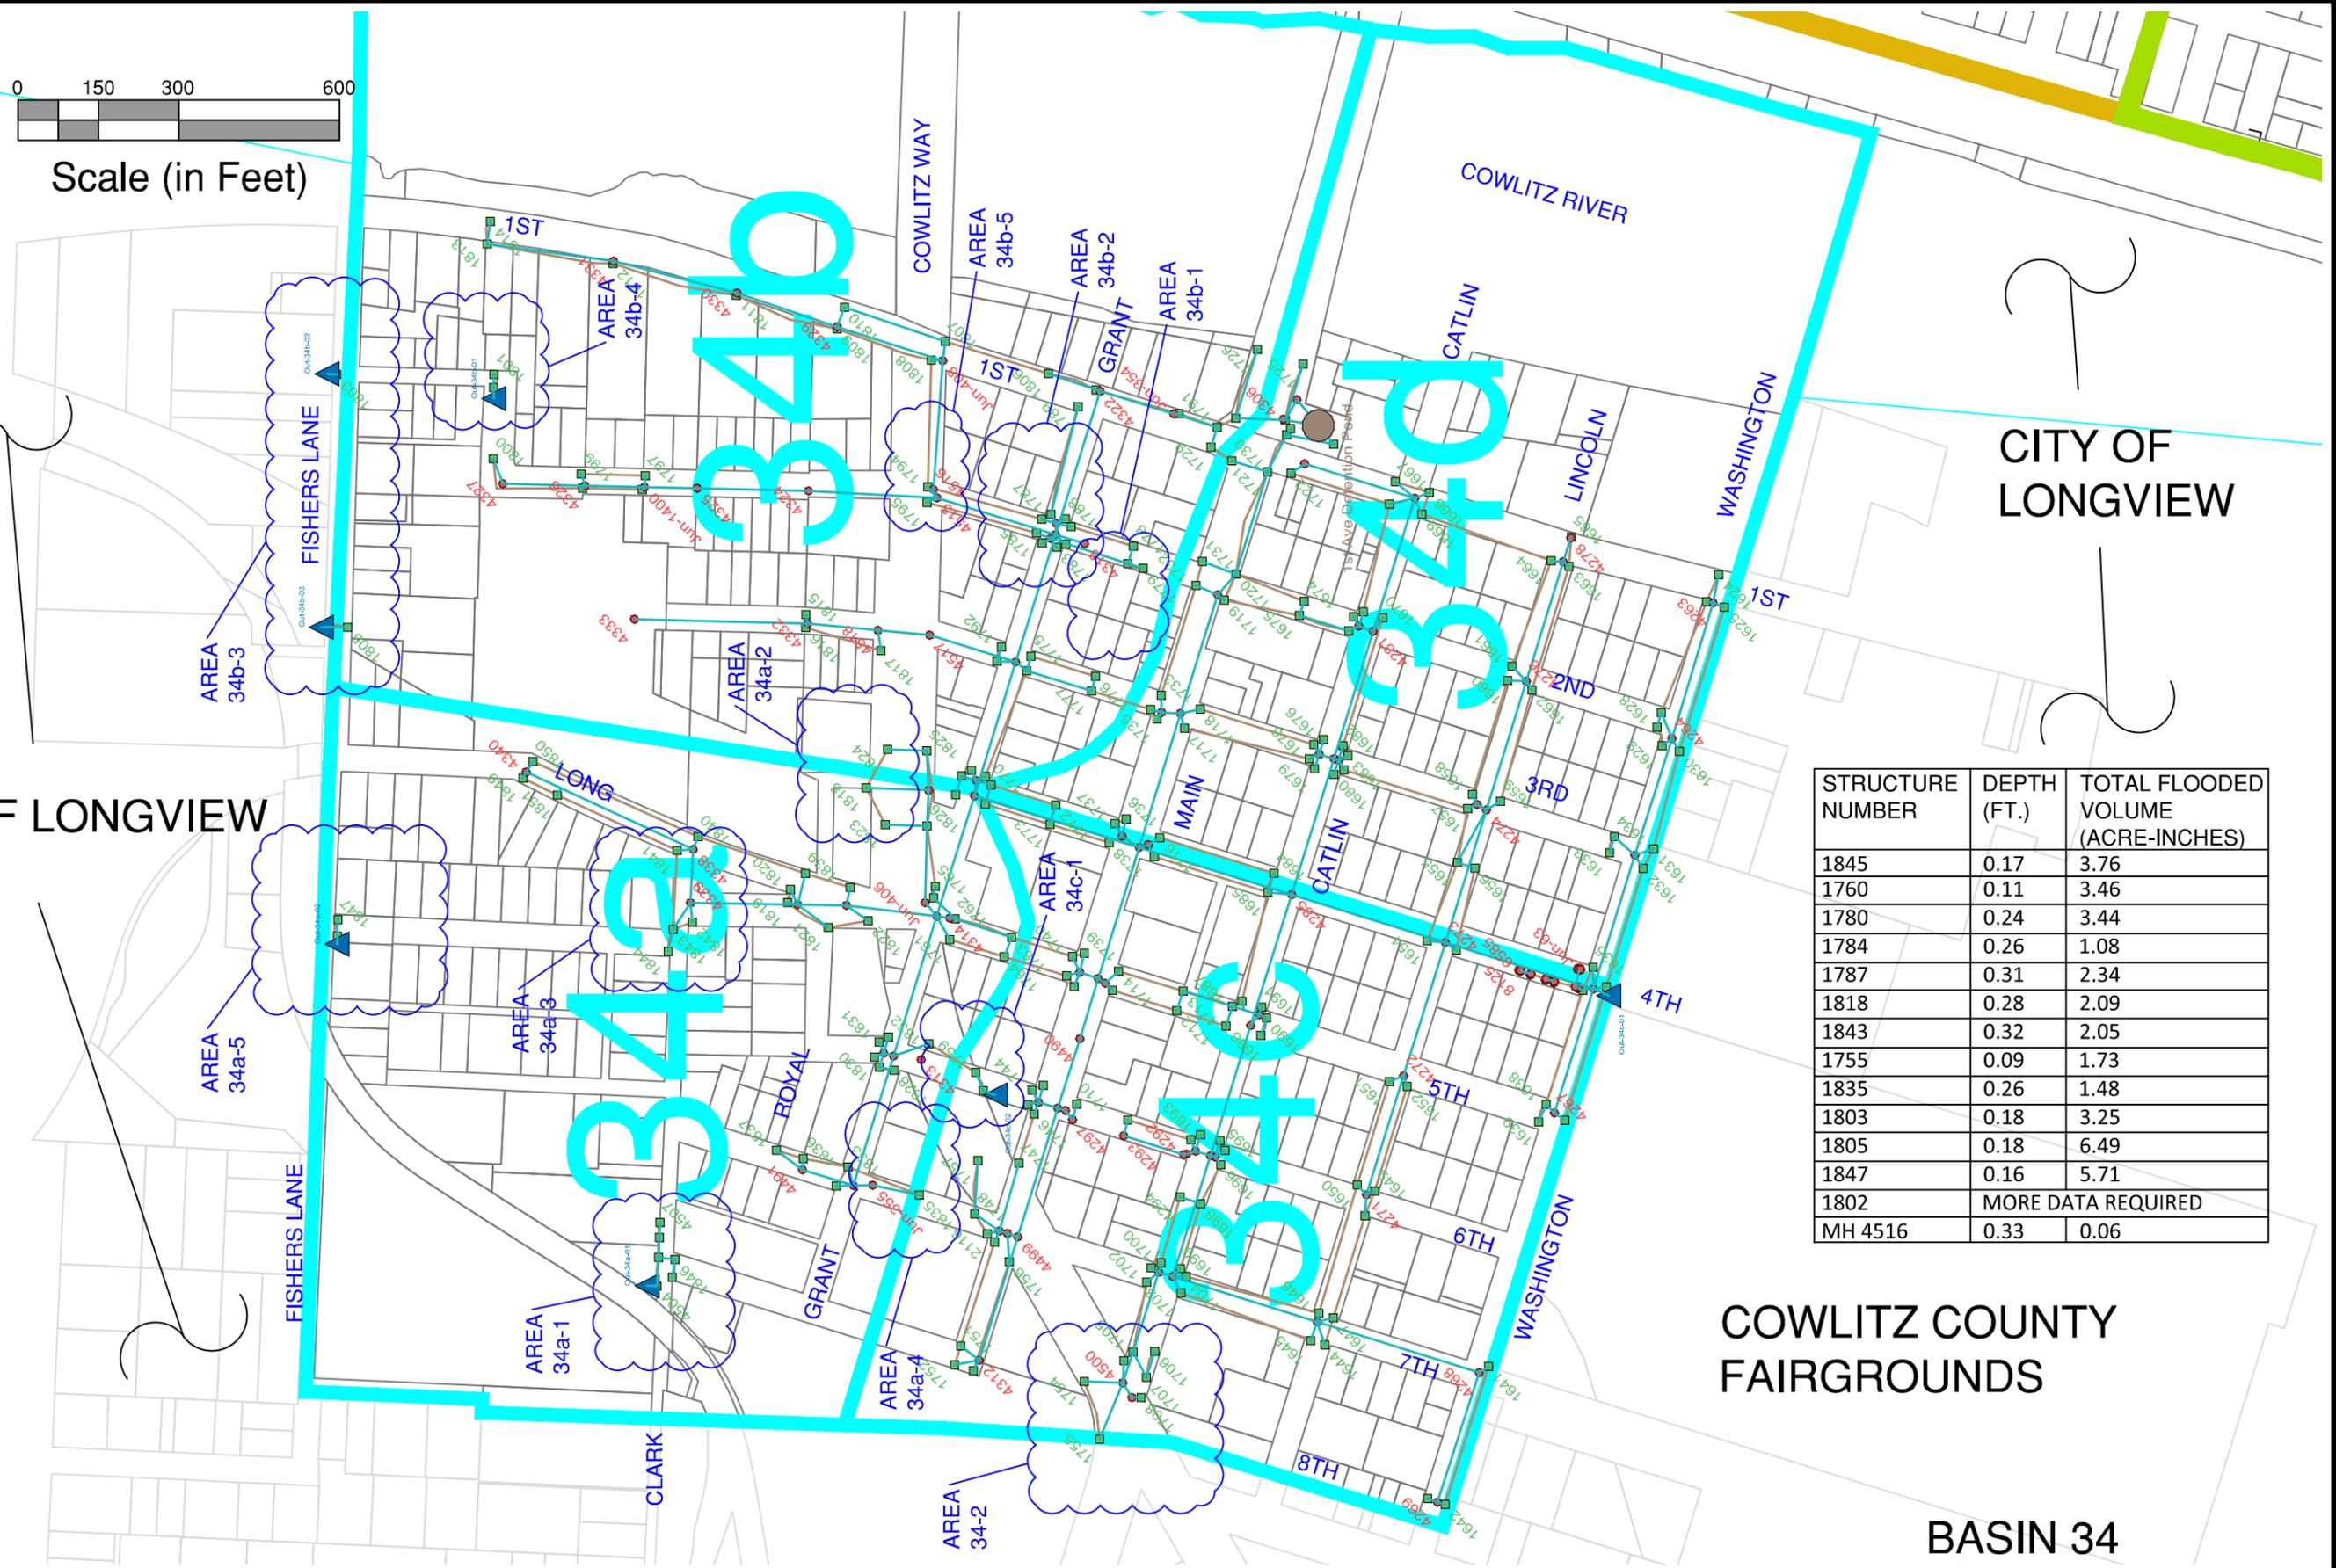
STRUCTURE NUMBER	DEPTH (FT.)	TOTAL FLOODED VOLUME (ACRE-INCHES)
1845	0.17	3.76
1760	0.11	3.46
1780	0.24	3.44
1784	0.26	1.08
1787	0.31	2.34
1818	0.28	2.09
1843	0.32	2.05
1755	0.09	1.73
1835	0.26	1.48
1803	0.18	3.25
1805	0.18	6.49
1847	0.16	5.71
1802	MORE DATA REQUIRED	
MH 4516	0.33	0.06

### BASIN 34

The west Kelso basin has a series of small stormwater collection system deficiencies but does not have significant flooding issues. Even with the 100-year storm event, there are very few places where surcharging of the system occurs. Some of the visual reports of areas that surcharge are not validated by the model, which indicates that some of the drainage structures may be damaged or need cleaning. The areas that show limited surcharging are described in Attachment 2 of Appendix A, the modeling results discussion, but not included in the Capital Improvement Plan recommendations because of the low significance.

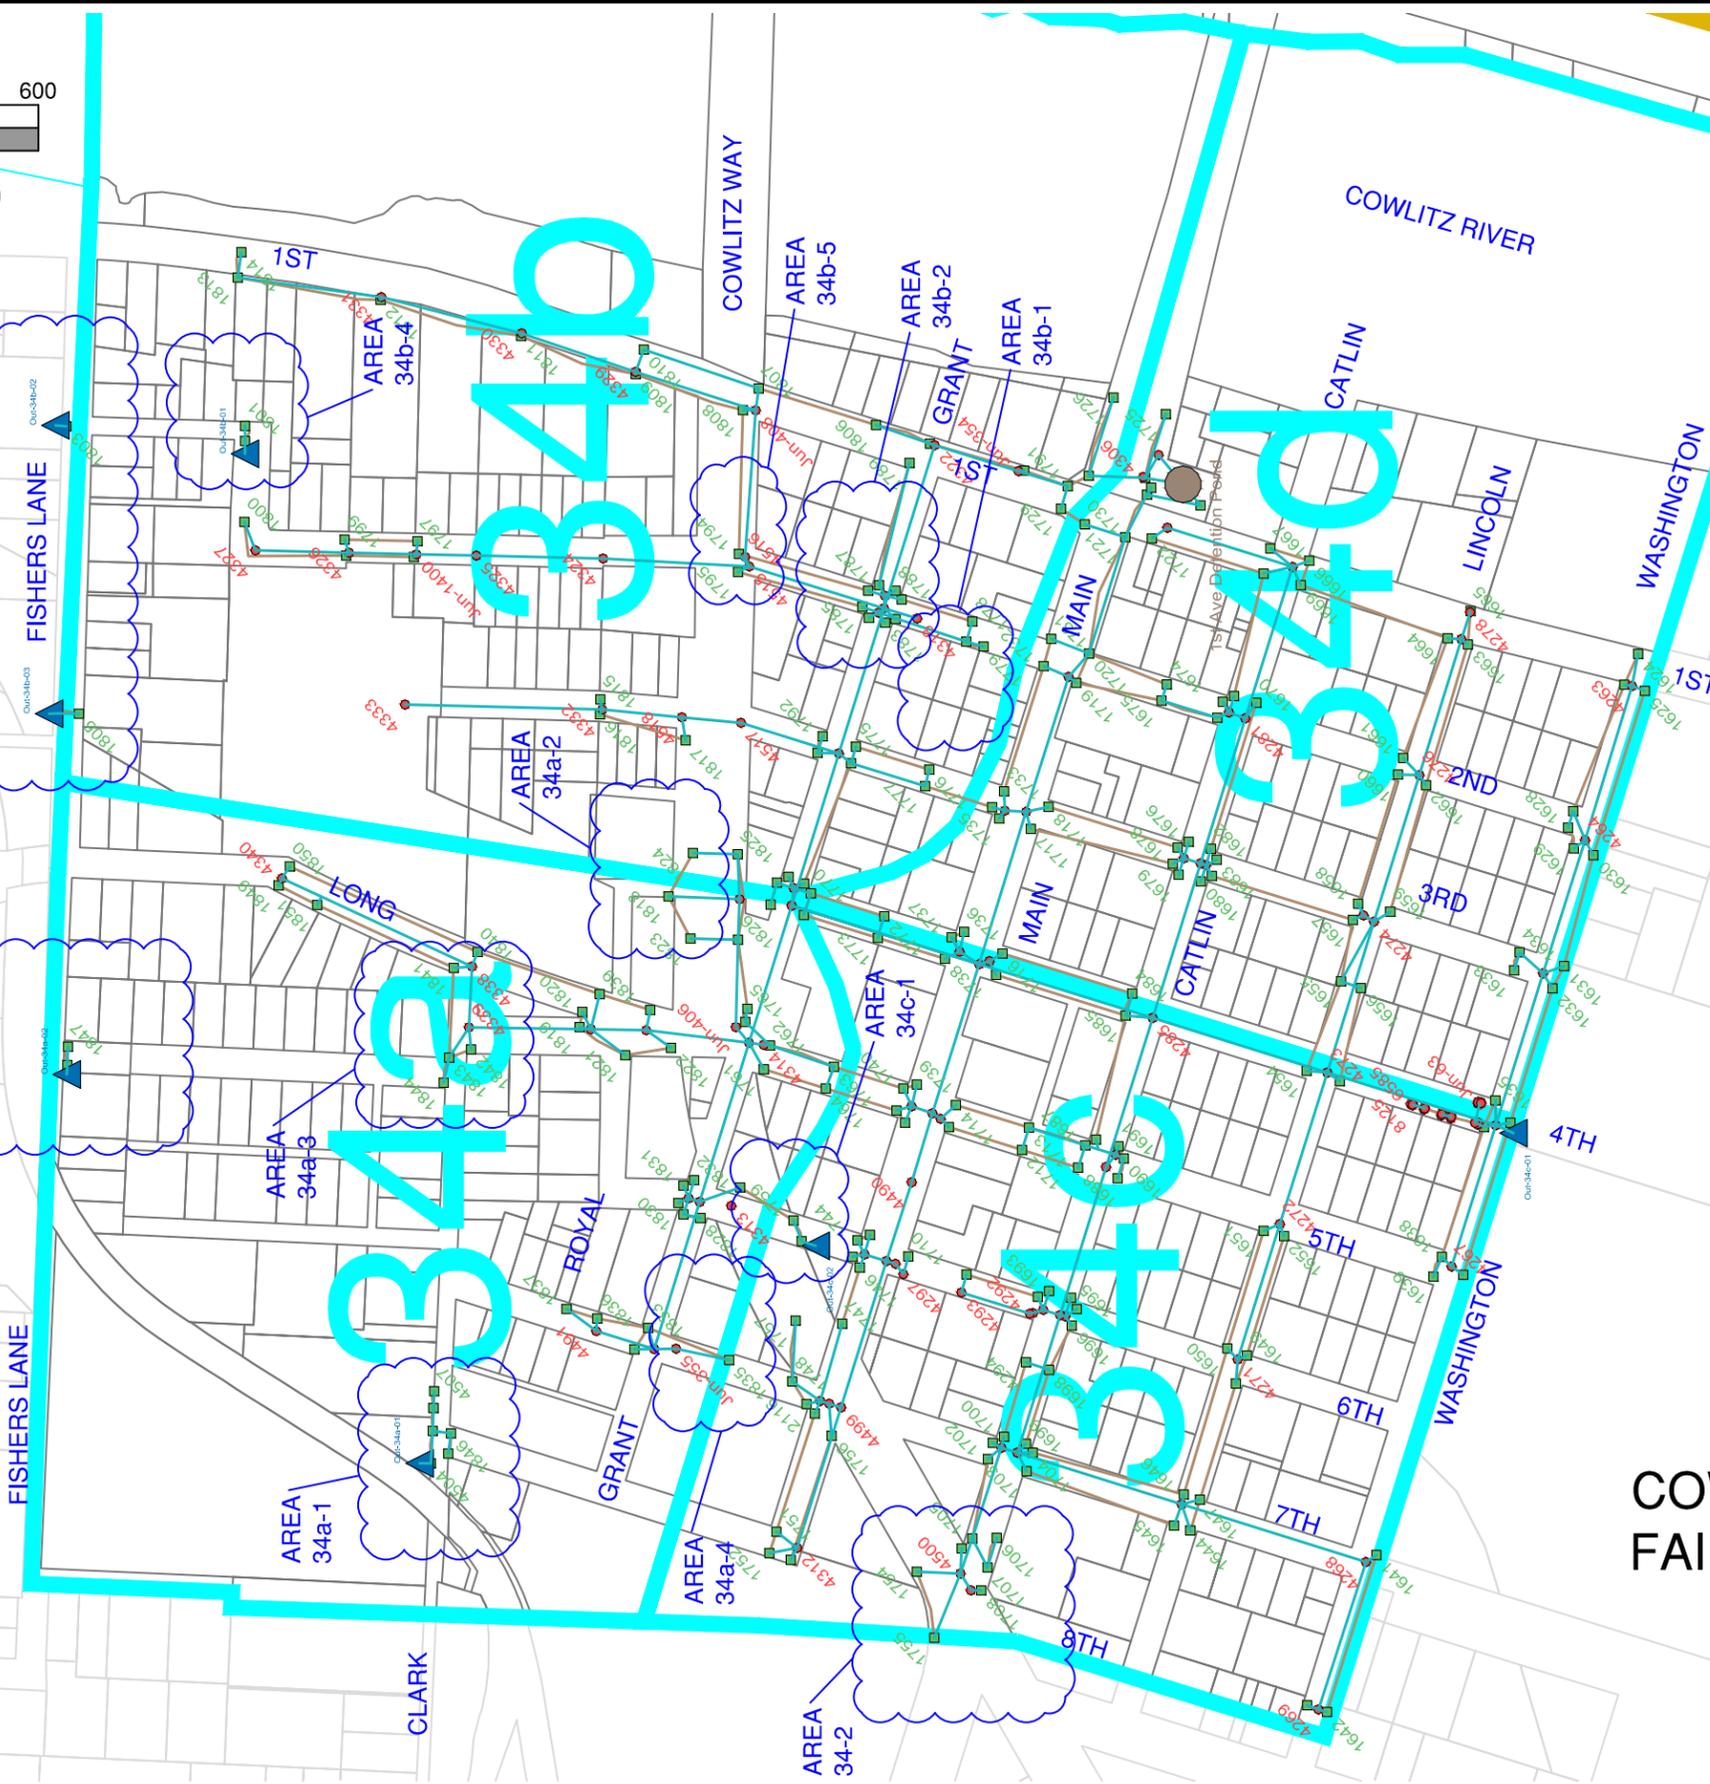
City of Kelso  
Stormwater Management Plan, Phase III  
West Kelso Watershed Areas of Concern, 100-Year Storm  
Figure A-3c

STRUCTURE NUMBER	DEPTH (FT.)	TOTAL FLOODED VOLUME (ACRE-INCHES)
1845	0.25	5.81
1760	0.16	5.07
1780	0.33	8.13
1784	0.33	2.68
1787	0.37	5.98
1818	0.34	5.08
1843	0.37	5.02
1755	0.14	4.08
1835	0.33	3.50
1803	0.18	3.25
1805	0.18	6.49
1847	0.16	5.71
1802	MORE DATA REQUIRED	
MH 4516	0.37	1.31

### BASIN 34
